### **Confidential Home Inspection Report**

625 N 7th St  
Upper Sandusky, OH, 43351

Inspection ID: WMS Realty 7th Street  
Date: 03/15/2019

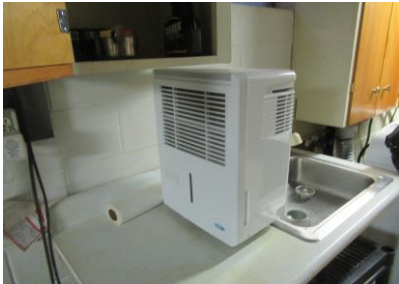
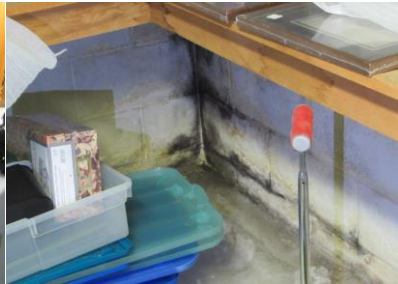
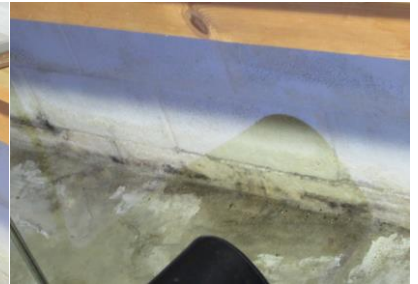
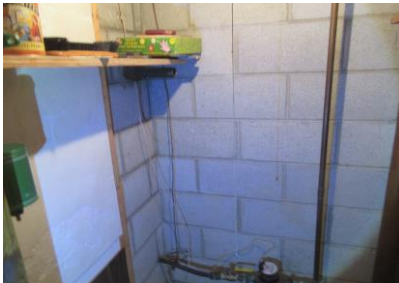
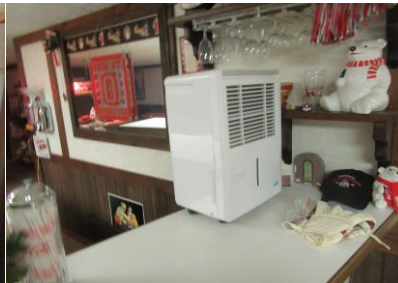
Some of the basement is finished so there are only certain areas the concrete block could be seen. The block that could be seen has no major cracks and is straight. There is some signs of water seepage especially in the back corner. There may be possible fungal growth and this can be tested for mold if there is a mold allergy. The basement does have two dehumidifiers and keeping the humidity between 35 and 50% is best to help keep occupants healthier.

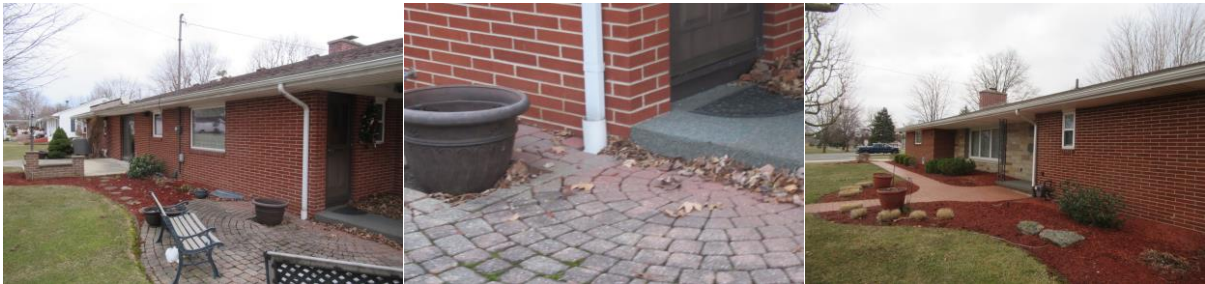
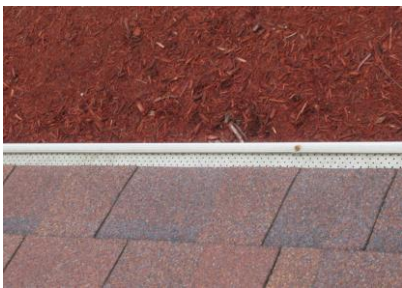
The gutters all have leaf guards on them to keep them clear. The front gutter only has one downspout and the back has two downspouts. One 2x3 downspout will drain 600 square feet of roof and one 3x4 downspout will drain 1200 square feet of roof. With only one downspout in the front a bigger downspout would help a lot for the hard rains. The downspouts all run into underground pipes.

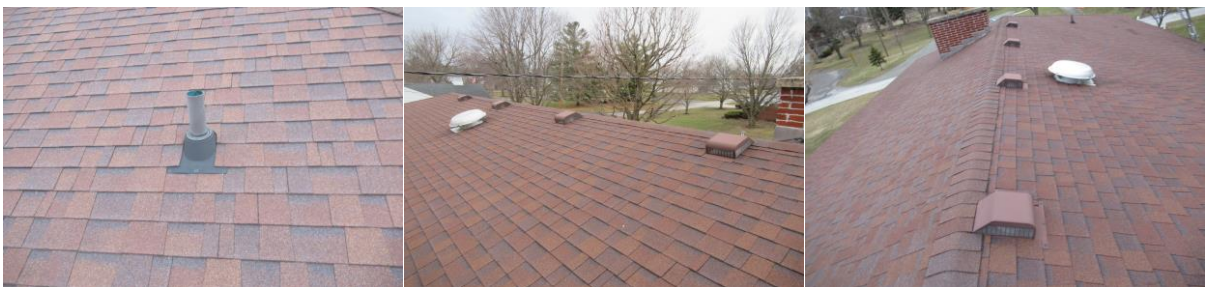
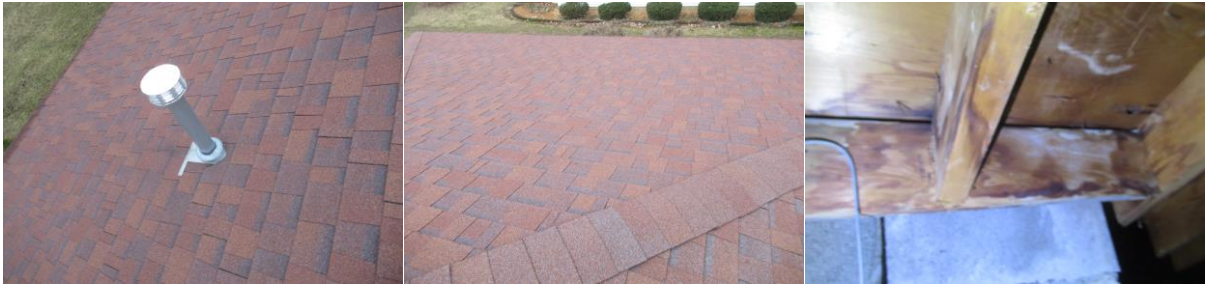
The shingles are sealed down and have most of their protective stone on them. The pipe flashings all look good. The roof is vented by some hat vents and one power roof vent on the back side of the roof. In the attic there is a small area of moisture on the wood at the chimney. I did not find any crack in the chimney flashing, only in the chimney cap. I did not see a full and fast leak, only what appears to be water seeping in and this may need looked at and sealed.

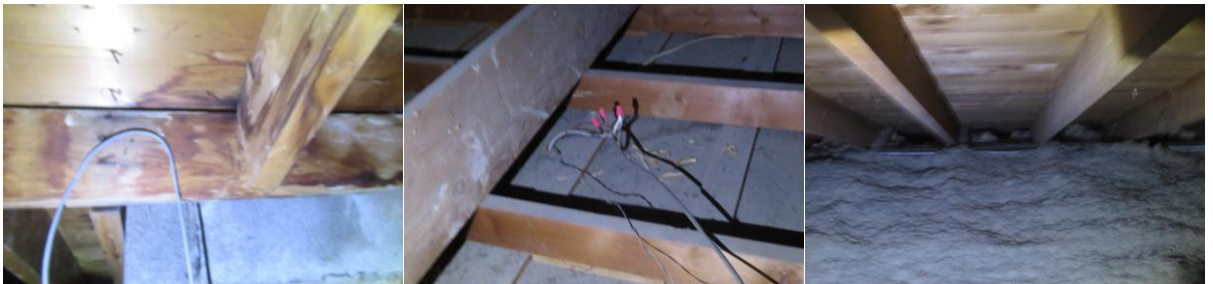
The attic does have some insulation. The attic is vented and the soffit vents are not plugged by insulation. There is some moisture on the wood around the chimney. I did not find a fast leak, only what I would say is some water seeping into the attic area. There is a wire junction in the attic above the garage door opener that should have an electrical junction box added for the junction.

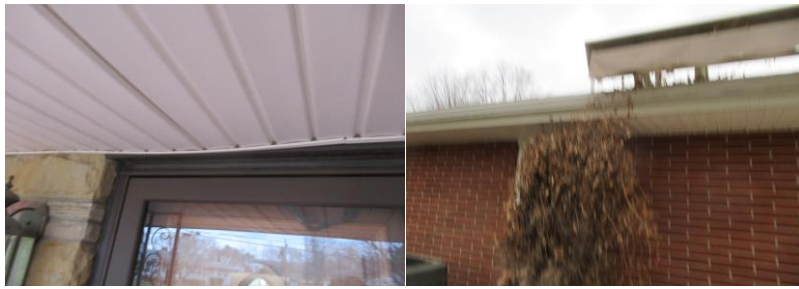
The soffit is loose and hanging down some above the front door. On the back there is a vine that is growing up onto the roof and into the back awning.

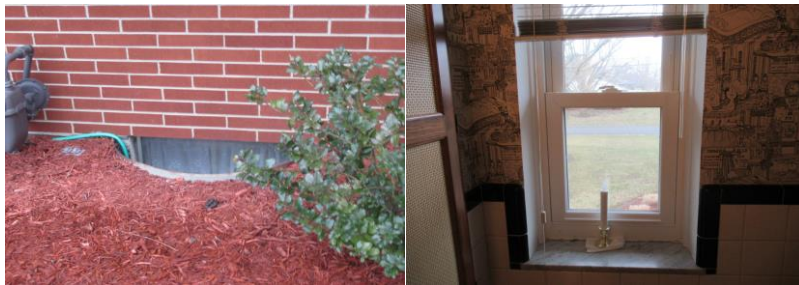
The windows on the main floor are all vinyl frame with LowE coated double pane insulated glass. One of the basement window wells has no cover and there is a hose coming out of it that runs into the mulch.

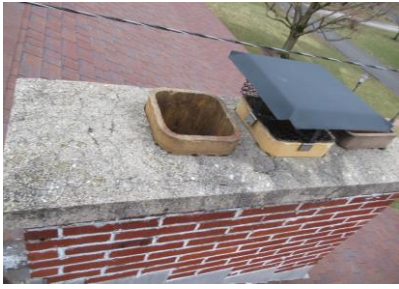
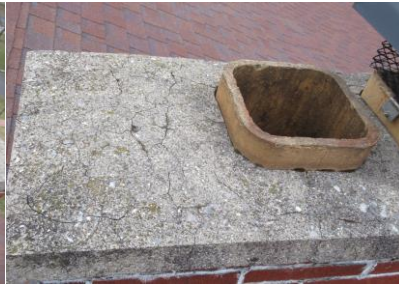
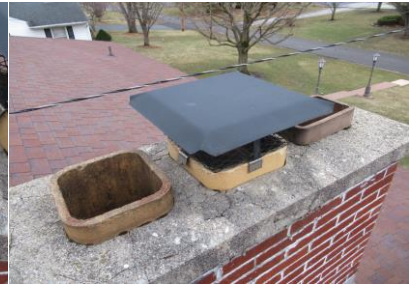
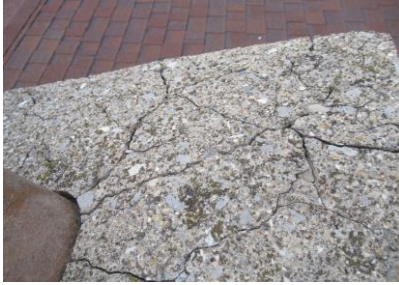
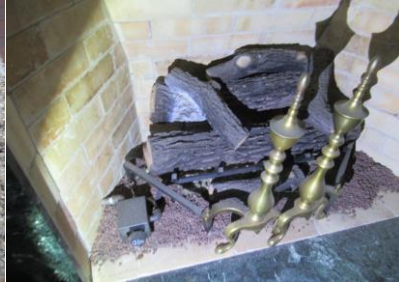
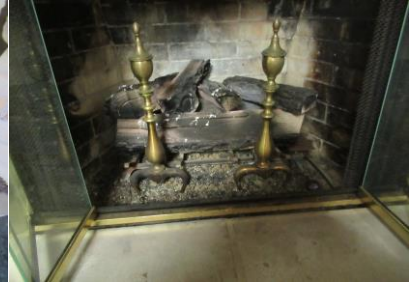
The home has two gas fireplaces, one on the main level and one in the basement. I could not get the ignitor to light in either fireplace and they could be serviced. The chimney is brick and concrete and has a cap on the middle flu. The concrete chimney cap does have some small cracks in it that should be sealed or caulked to keep water out of the cracks and making them worse.

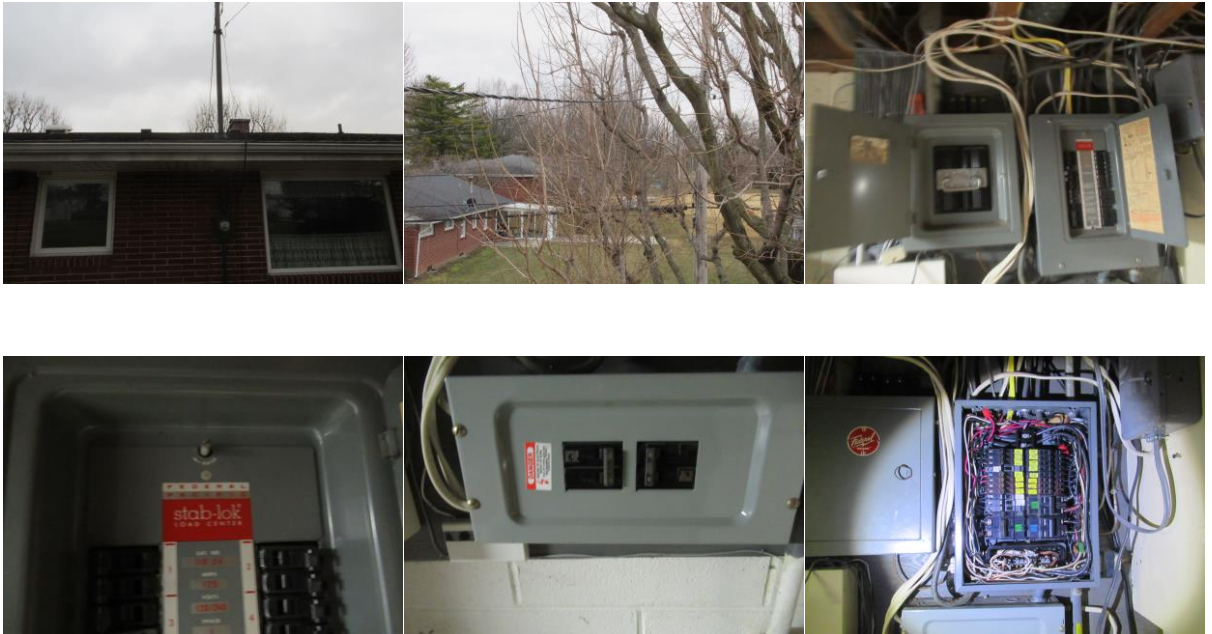
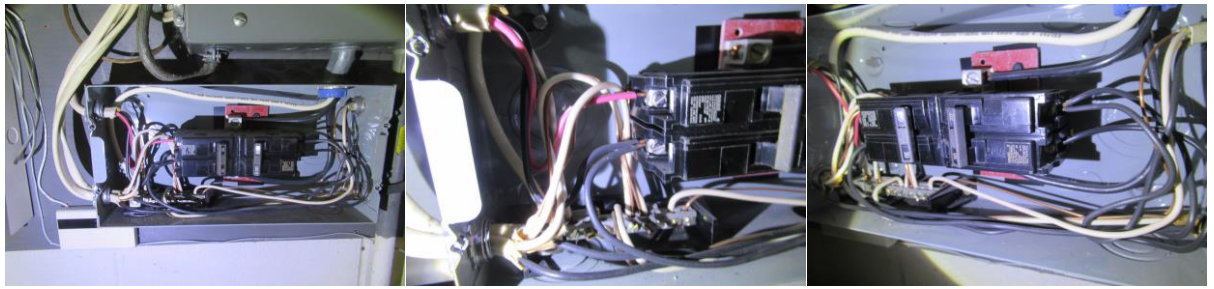
Home has a 100amp service with a 100amp Federal Pacific pull fused main service panel. 100amp is the minimum service a home should have. The service wire does run through a tree between the home and the street. This could cause some issues during high wind. The home has a 100amp Federal Pacific Stab Lock circuit breaker service panel after the fused pull. The stab lock breakers have had trouble in the past. You can still order aftermarket breakers to fit these panels but it is getting increasingly harder and more expensive to get these breakers. Some insurance companies consider these breakers to be a hazard. There is a 60amp Gould subpanel under the service panel and it has two breakers which are both double tapped (two wires on one breaker) that should be split up. I would consider a new service panel and I would also consider possibly upgrading to a 200amp system.

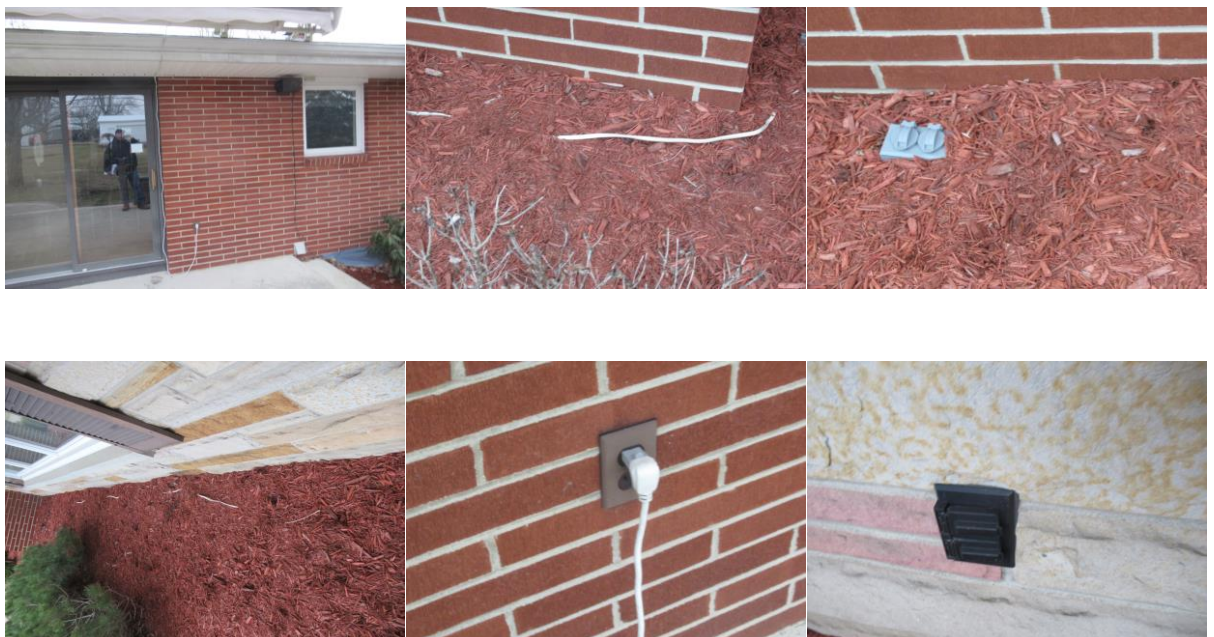
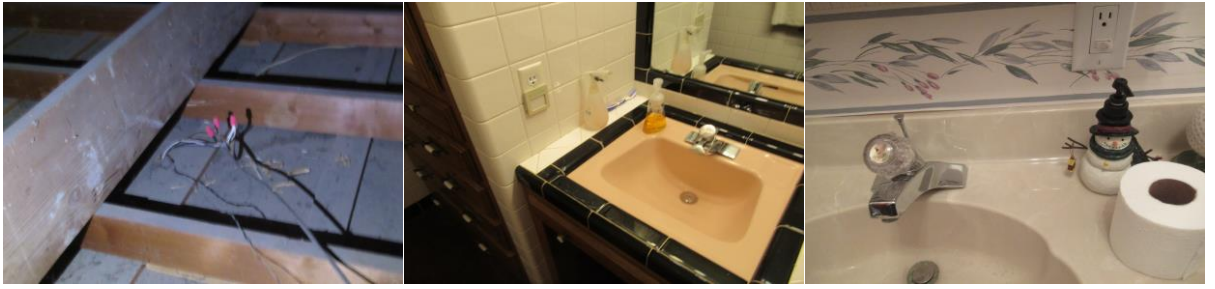
The back awning has an extension cord on the exterior. Permanent fixtures should be direct wired in and not be powered by an extension cord. The front outlets in the mulch are all powered by an extension cord that runs in the mulch and into an exterior outlet. Extension cords should only be temporary and this should be upgraded to permanent wiring in conduit for the exterior front outlets. There are no GFCI (Ground Fault Circuit Interrupter) protected outlets in the kitchen, bathrooms, or exterior areas. About half of the outlets are grounded and half are open ground. Three prong cords should only be plugged into grounded outlets and two prong cords can be plugged into all of them. In the attic above the garage door opener there is a wire junction that should have an electrical box put in and joined properly.

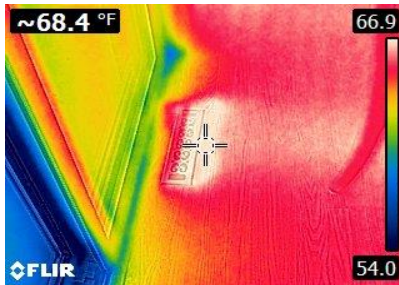
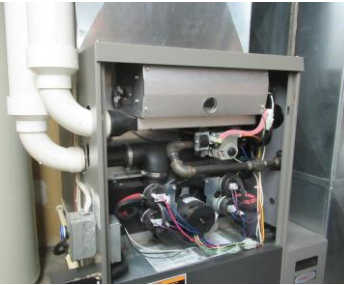
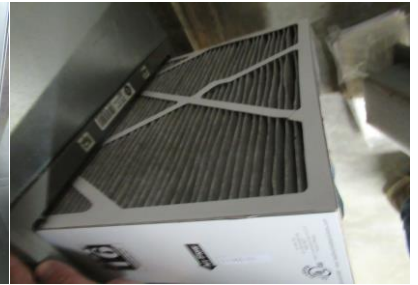
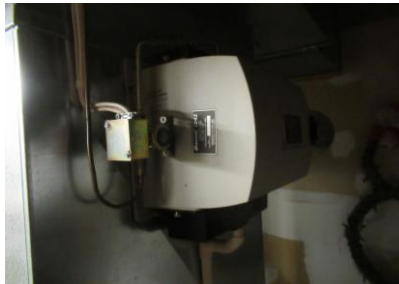
The high efficient Lennox furnace is dated at 2006. The thermal imaging showed heat coming out of the vents indication the furnace is operational. The furnace is clean inside and the air filter is clean. There is a humidifier on the furnace. These work well to add humidity to the heat. They do need serviced as when the furnace is not used the filter in the humidifier can get mold growth. All HVAC equipment does need serviced at least once a year.

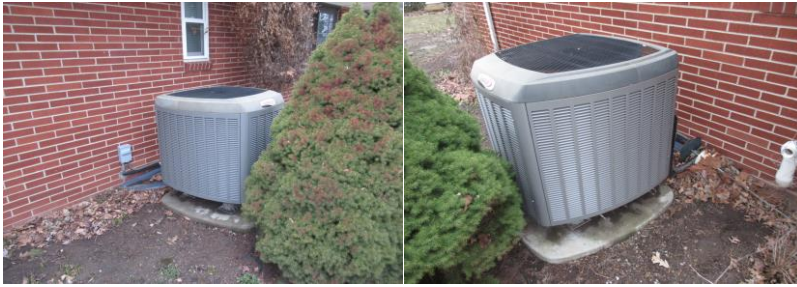
The Lennox Condenser is date at 2006. The condenser is on a pad and the exterior pipe is insulated. I did not run the A/C due to when the outside temperature is below 65 degrees running the A/C can damage the condenser.

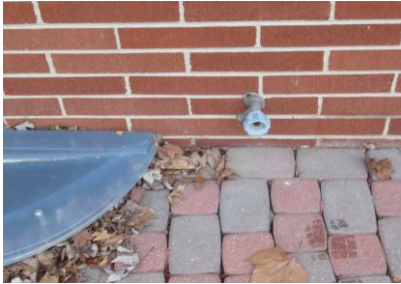
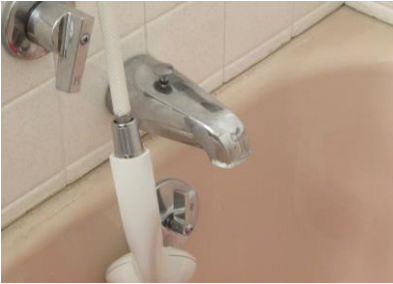
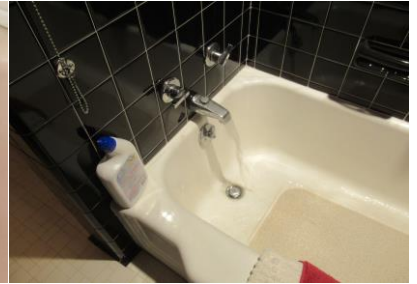
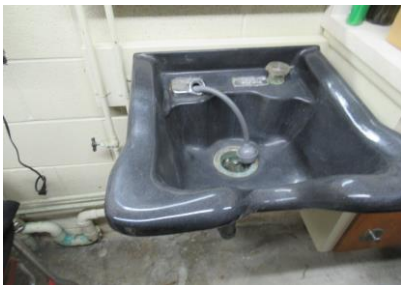
Most of the water fixtures do have good pressure. The exterior water spigot on the back has a handle that will not turn. There is some corrosion on the master bath tub spout. The back full bath spout does not have full water pressure when turned on indicating there is some corrosion in the spout. The basement sink by the laundry did not come on.

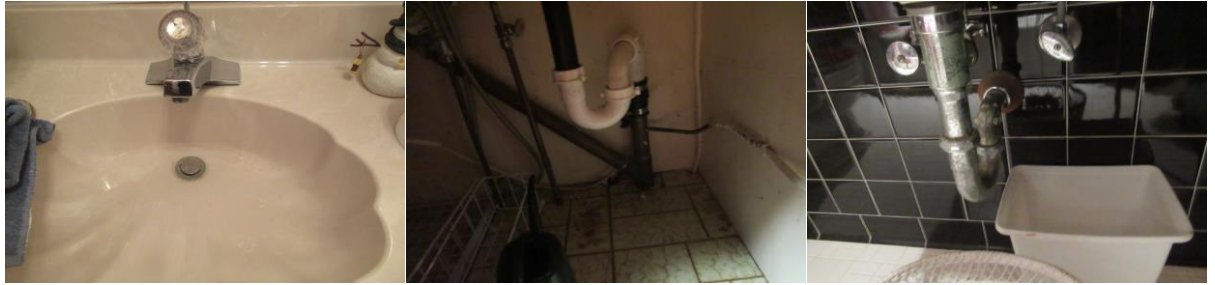
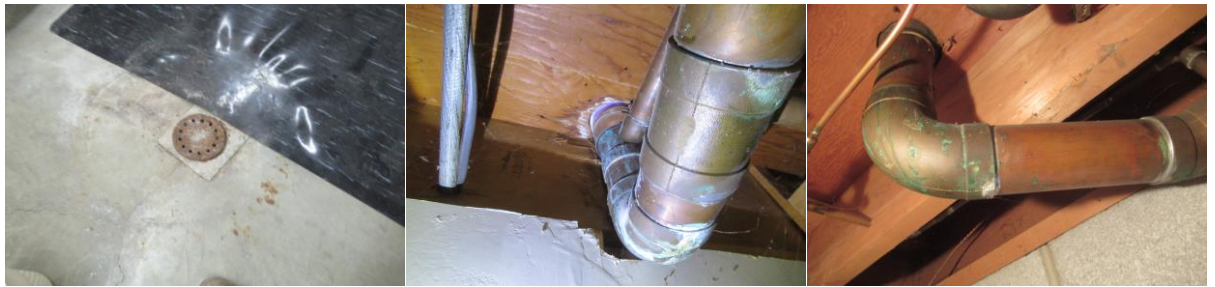
The bathroom sink drains slowly in the half bath. The kitchen sink has an S-trap. Newer homes have P-style traps and most of the traps on this home are P-style. S-style traps are not used anymore due to on rare occasions a vacuum can occur and suck all of the water out of the trap allowing sewer gas to come up through. The back full bath sink has a metal trap with a little corrosion. The basement floor drain is corroded. The drain lines are copper and I found no leaks in the drains at this time.

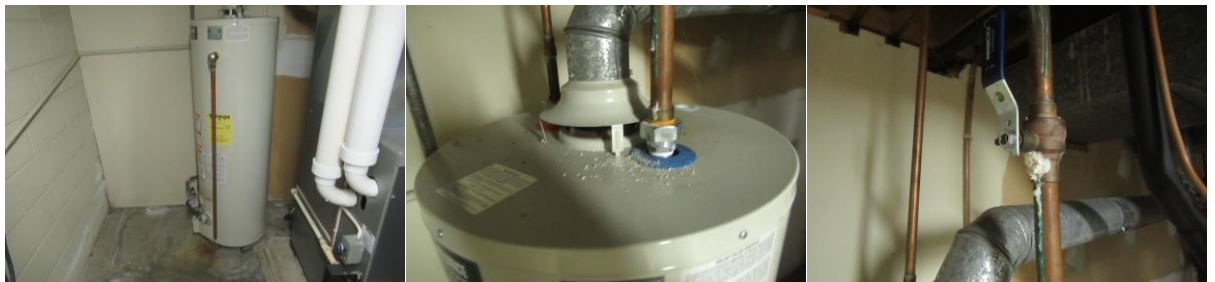
The Reliance water heater is dated at 2008. The water heater is operational. There is a lot of corrosion on the shut off valve above the water heater and that valve should be replaced.

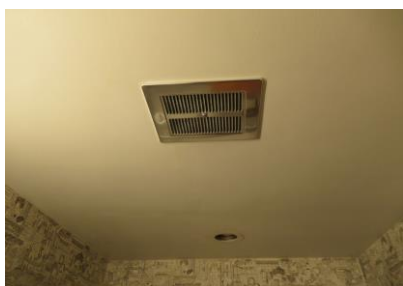
The master bathroom vent is not operational and needs repaired or replaced.

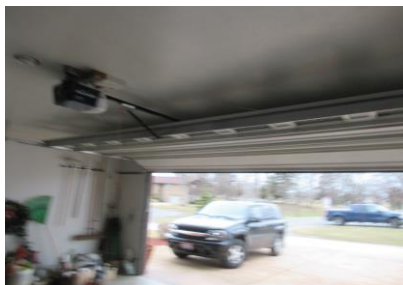
The garage door opener and safety beam are operational.
