Confidential Home Inspection Report

5343 State Route 95
Mount Gilead, OH, 43338

Inspection ID: WMS Realty Mount Gilead
Date: 04/20/2019

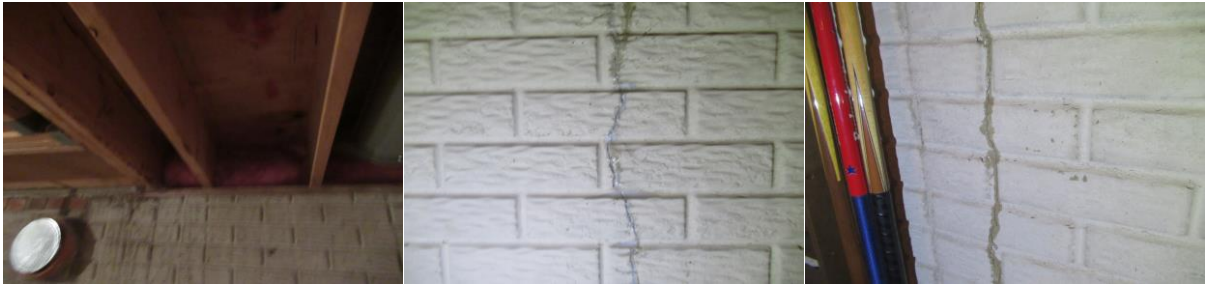
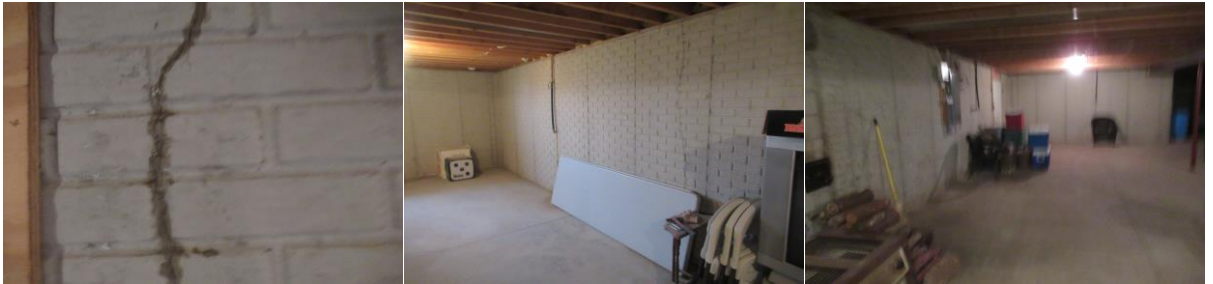
A. Foundations

There are a few minor cracks that have been sealed. The walls are straight and there were no signs of water intrusion. The floor joists all look good and the floor box sills are insulated.

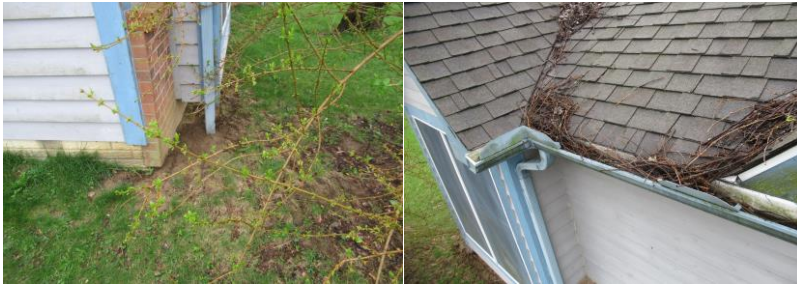
B. Grading and Drainage

The downspouts all run underground. The gutter is all clear except for the front by the tree is clogged and needs cleaned.

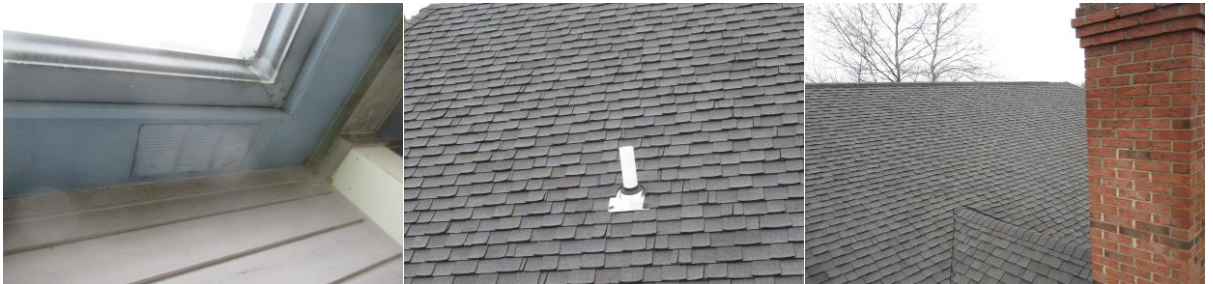
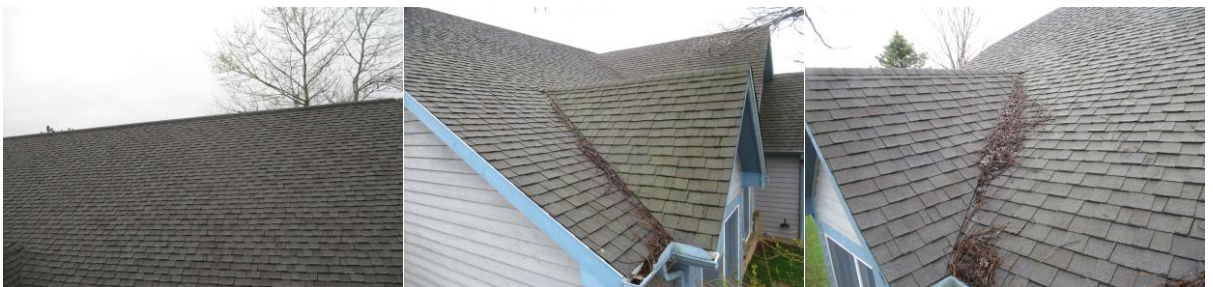
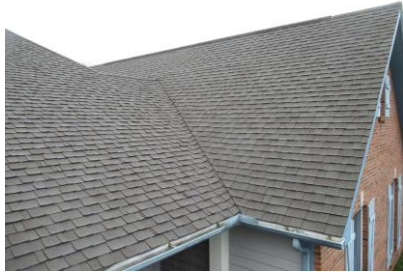
C. Roof Covering Materials

The roof shingles are sealed down good and the shingles do have most of their protective stone on them. The roof is ventilated by soffit and ridge vents. The pipe flashing looks ok. There is some moss or lichen growth on the roof in the front under the tree. There is also some branches and twigs on the roof. These should be cleaned off of the roof as they hold moisture. Tree limbs should be trimmed back from the roof as they can damage the shingles in high wind.

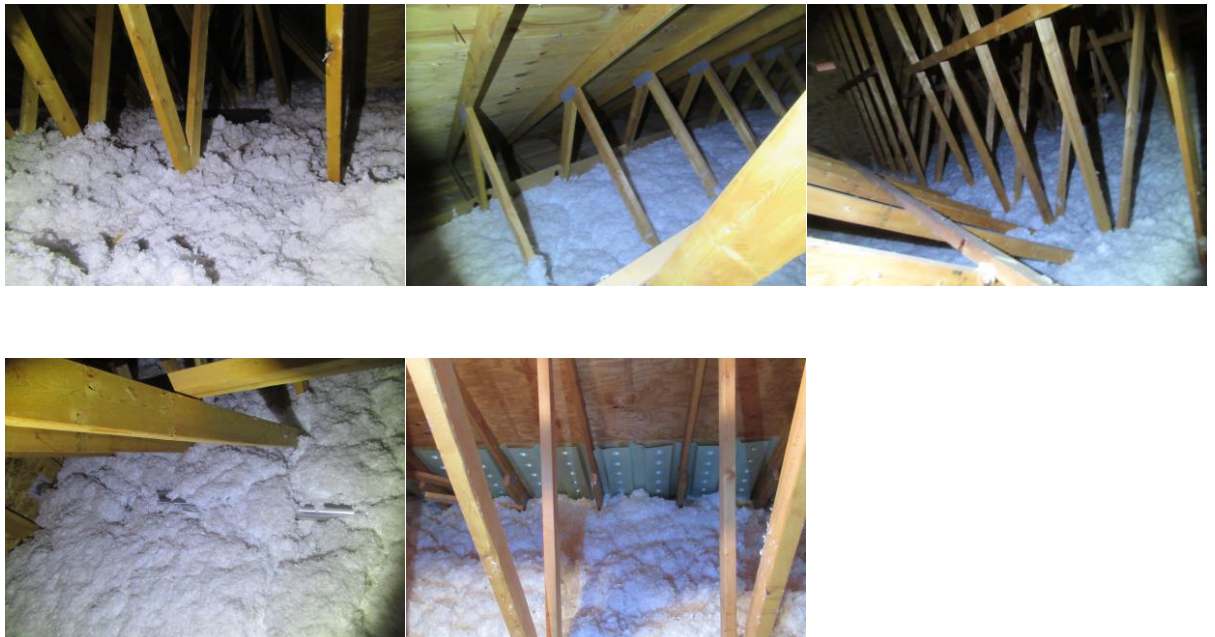
D. Roof Structures and Attics

The attic is insulated well with blown insulation. The bath vents are ducted to the exterior. The soffit ends have panels or strips to keep the insulation from blocking the soffit vents.

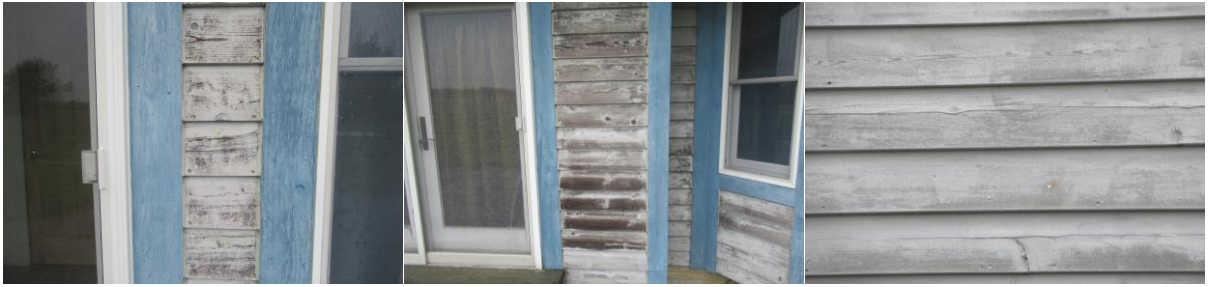
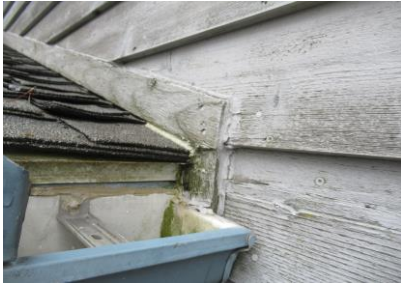
E. Walls (Interior and Exterior)

The home has wood siding and there are a few cracked pieces which is normal. All of the wood finish is wearing off and the back of the home has the most wear on the wood finish. The only soft spot in the siding I found was up by the gutter where there is a lot of water run off from the roof, a kickout flashing between the gutter and roof would help this area.

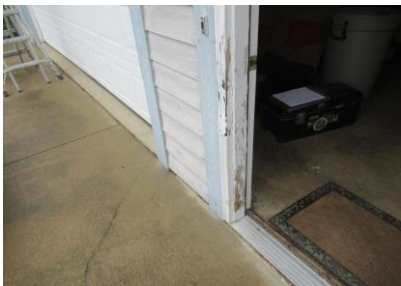
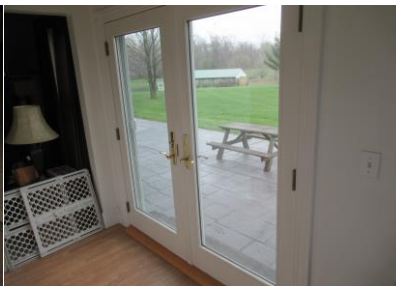
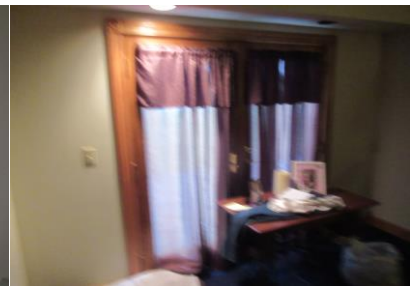
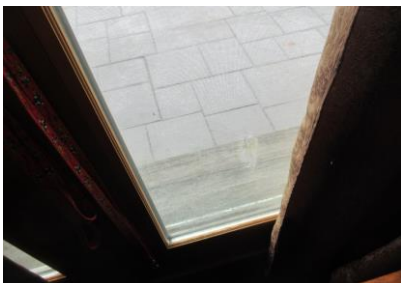
G. Doors (Interior and Exterior)

The exterior door jambs have peeling paint. The two back patio swing doors are sagging in the middle some causing them to be hard to open. This is normal for swinging patio doors. The doors all do have Low E Coated double pane insulated glass. The screen on one of the doors has a bigger size hole.

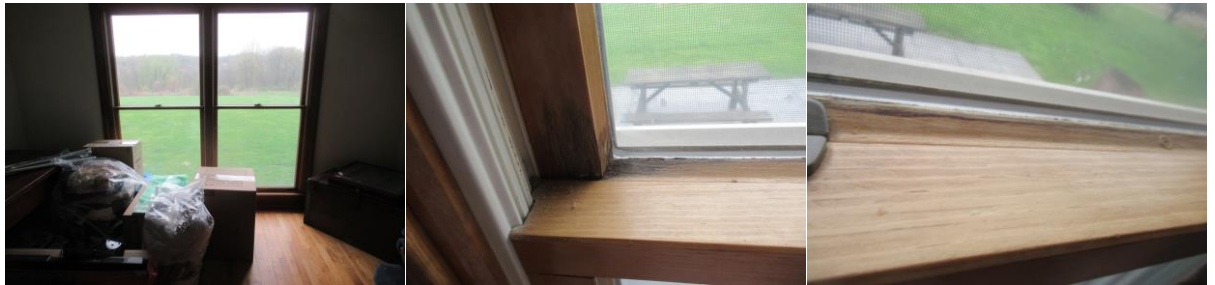
H. Windows

The windows are double hung style and all have Low E Coated double pane insulated glass. A few of the windows do have small water stain in the corners and on the sash that is probably due to condensation on the window glass. This is normal and I found no soft wood on the windows. The front windows are low to the floor and I did not see a tempered glass symbol in the window. Some locals have codes on low windows having tempered glass and some do not. This can be a safety issue if someone falls into the low window. The original builder or owner would have to be asked if they used tempered glass on these windows if someone needs to know if they are tempered or not.

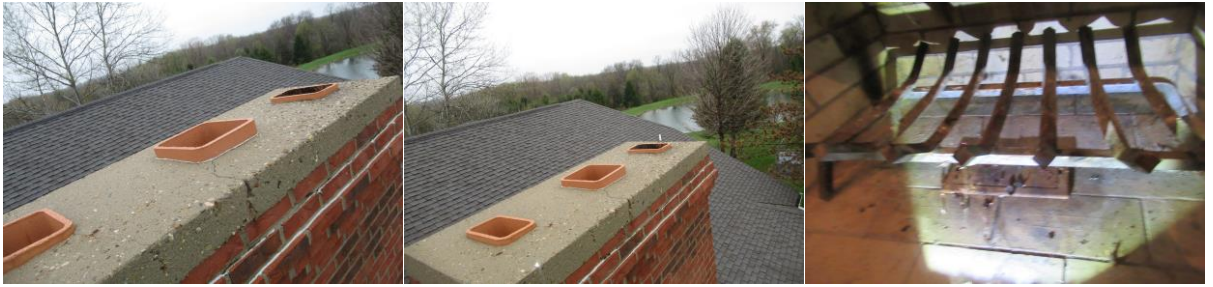
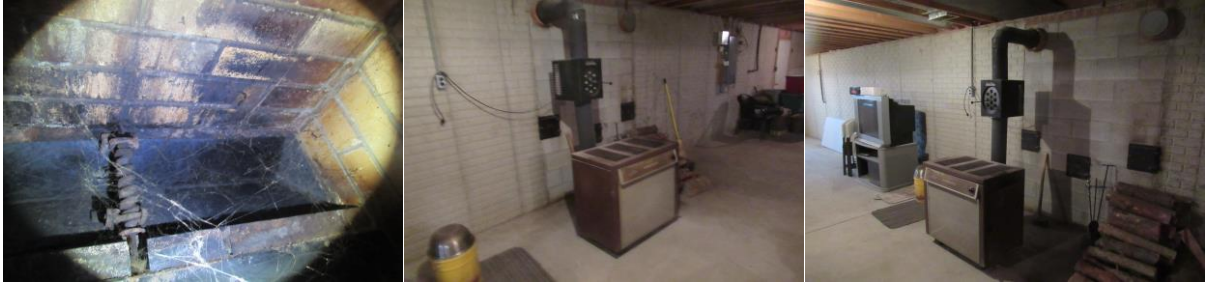
J. Fireplaces and Chimneys

There is a wood burning stove in the basement. Some insurance companies charge more for wood burning stoves. There is also a wood burning fireplace. The damper is operational. If wood is to be burned in the fireplace it is recommended to have the chimney professionally cleaned. There is some moisture in the damper and in the fireplace. This could be due to there are no caps on the chimney. The top of the chimney has a small crack in the concrete cap and this should be filled or caulked to keep water from penetrating and making the crack worse.

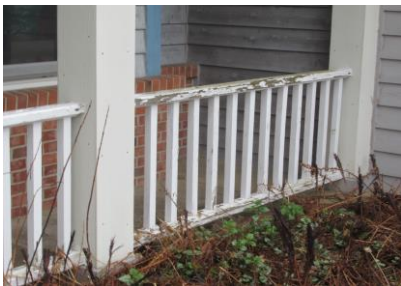
K. Porches, Balconies, Decks and Carports

The front porch railing has peeling paint.

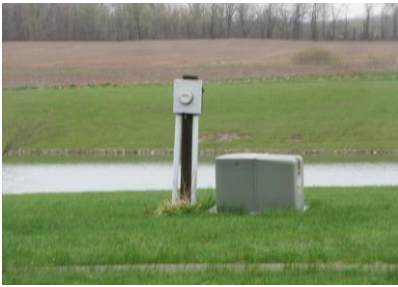
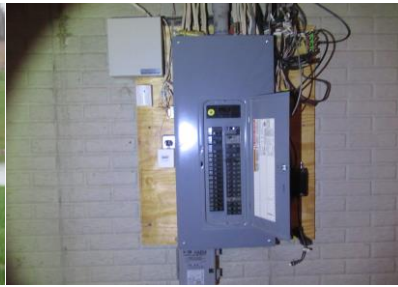
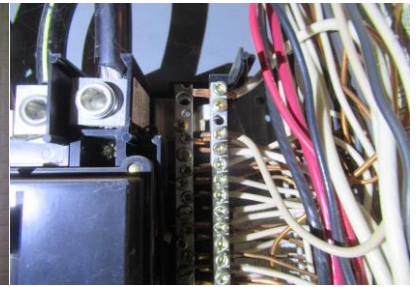
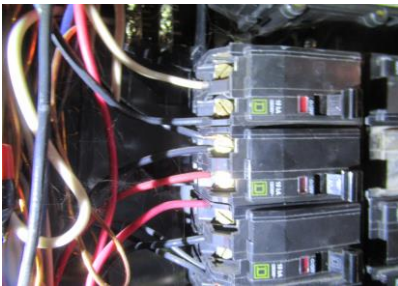
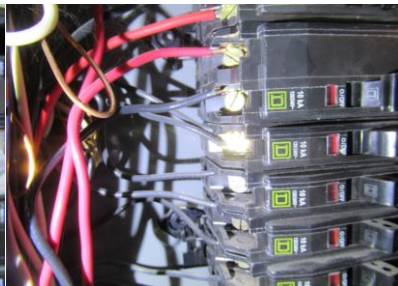
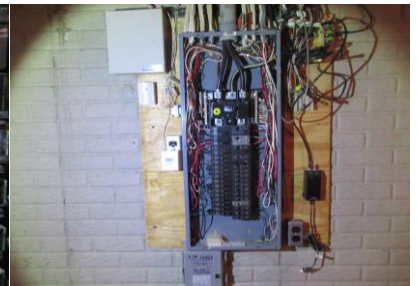
A. Service Entrance and Panels

The house has a 200amp meter with a 200amp service in the basement. The service panel is a Square D QO type panel. There should be a disconnect within six feet of the panel box between the meter and main service panel. I found no disconnect. The panel has a double tapped (two wires on one screw) neutral and has several double tapped breakers that should all be split up to one screw per wire.

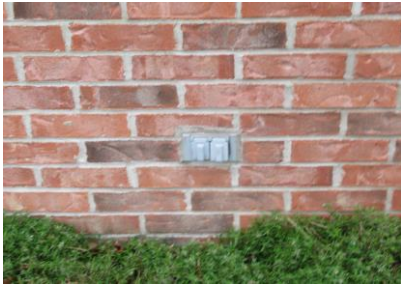
B. Branch Circuits, Connected Devices and Fixtures

Not all outlets could be tested as there was furniture and items in front of some outlets but all of the outlets that were tested were all grounded. The kitchen and bathrooms have GFCI (Ground Fault Circuit Interrupter) protected outlets but the exterior outlets are not GFCI protected and should be.

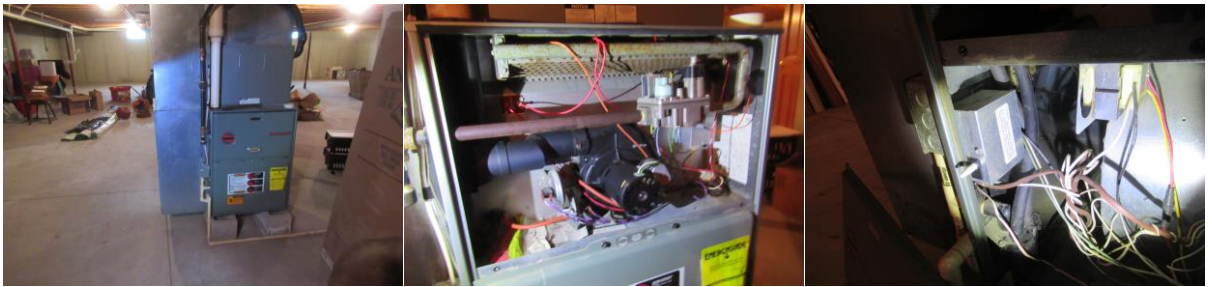
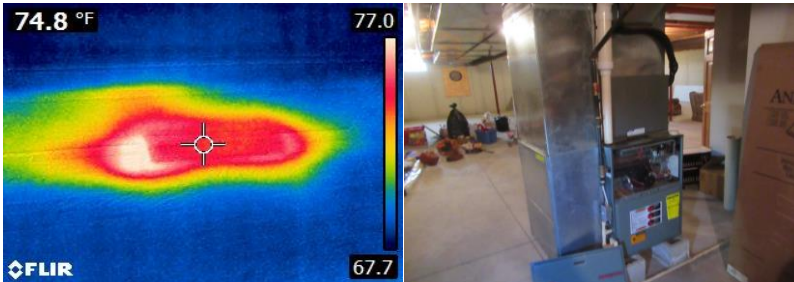
A. Heating Equipment

The high efficient Ruud furnace is dated at 1998. The furnace is operational and the thermal imaging did show heat coming out of the furnace. I did not find an air filter and in the furnace where there would normally be a filter there was none. There should be an air filter to the furnace. The average life expectancy for furnaces determined by testing is 20 years. All HVAC equipment should be serviced at least once a year.

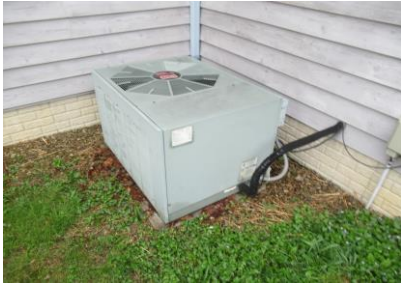
B. Cooling Equipment

The Ruud condenser is dated at 1999. The condenser is on a pad and the exterior line does have some worn insulation. I could not run the air due to the temperature as running the air when it is colder than 65 Degrees outside can damage the condenser. The average life expectancy of most air condenser as determined by testing is about 20 years.

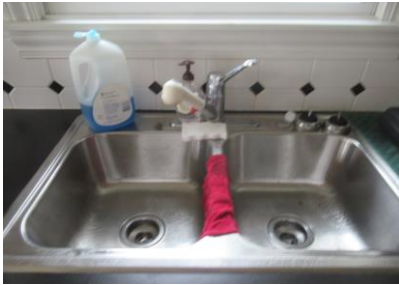
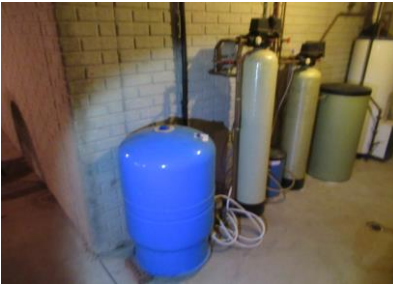
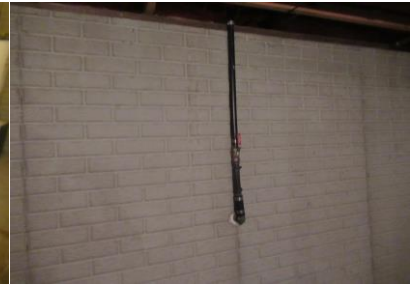
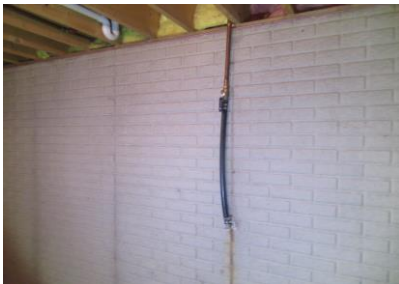
A. Plumbing Supply, Distribution Systems and Fixtures

The water fixtures all have good pressure except for the kitchen faucet. This faucet may need cleaned or looked at. I found no leaks in the water lines at the time of inspection. There is no corrosion on the well pressure tank.

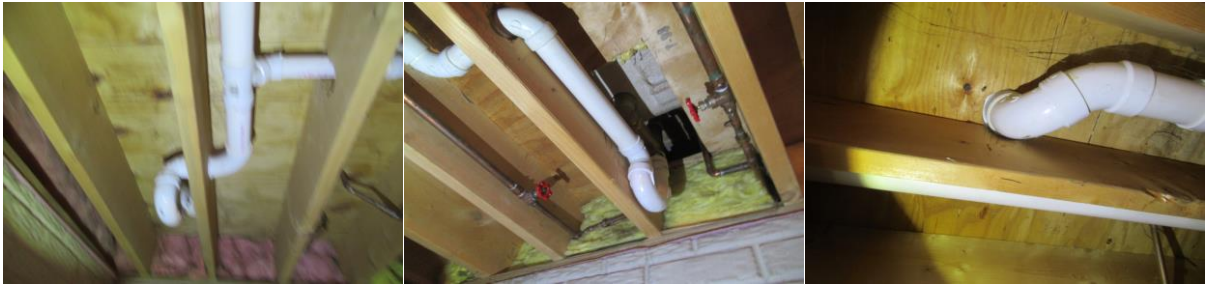
B. Drains, Wastes, and Vents

I found no leaks in the plumbing lines or traps at this time.

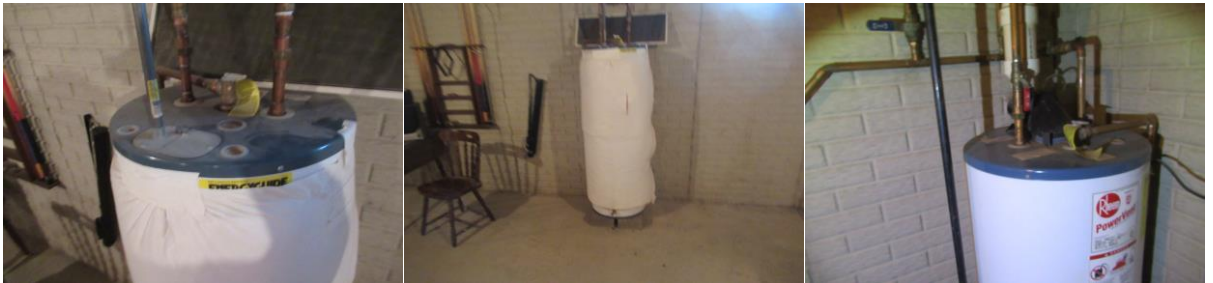
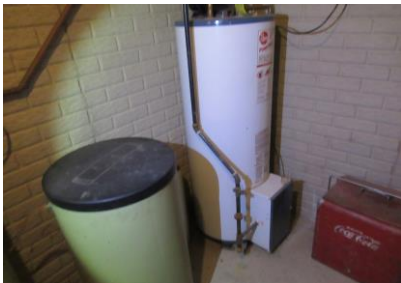
C. Water Heating Equipment

The 50 gallon tank is a power vent type water heater and is a Rheem brand that is dated at 1999. The other water heater is insulated with a blanket and the date could not be read. There is no corrosion on the water heaters and they are operational at this time.

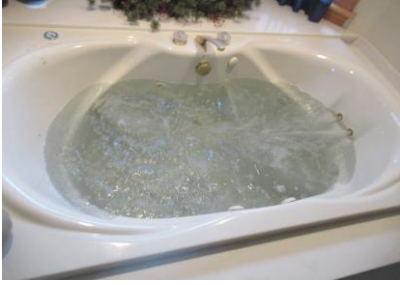
D. Hydro-Massage Therapy Equipment

There is a jetted tub. The jets were operational.

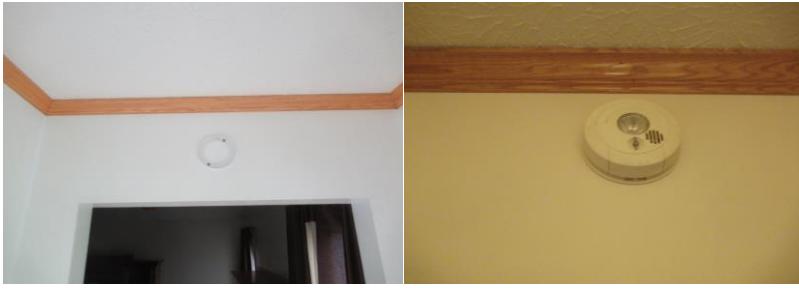
I. Other

The smoke that I found is operational. The other smoke alarm was missing. There are no carbon monoxide alarms and there should be one by the furnace and one by every sleeping area.
