Hermiller Home Inspections

Confidential Home Inspection Report

404 N Vance St
Carey, OH, 43316

Inspection ID: WMS Real Estate
Date: 01/09/2019

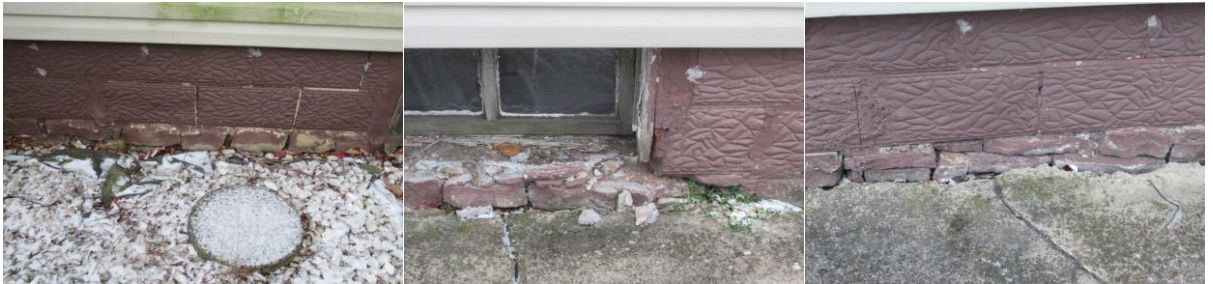
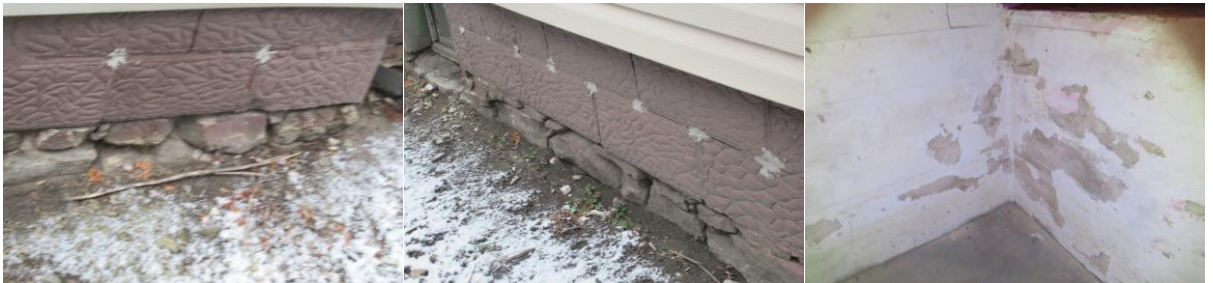
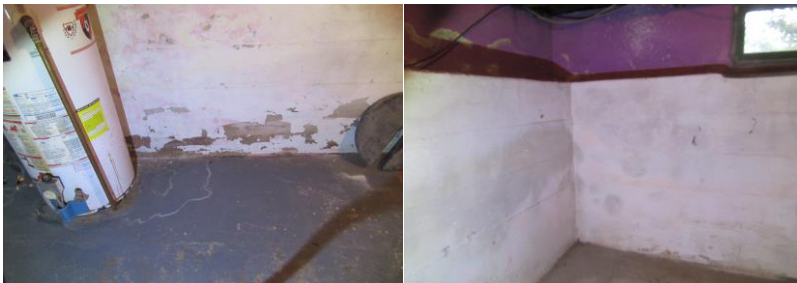
A. Foundations

The outside foundation has some stone with the mortar worn out of the joints. Some of the exterior foundation looks like it has some loose stone. The interior has concrete added on the inside. There is signs that water seeps in through the foundation. There is some paint peeled off on the inside and some water stains on the basement floor.

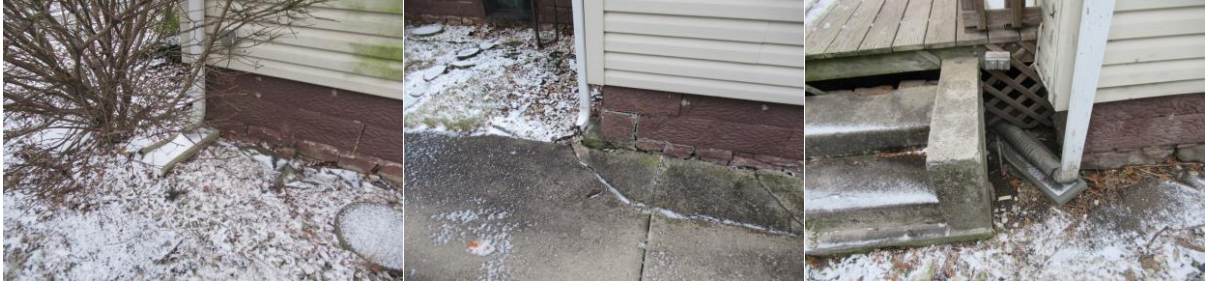
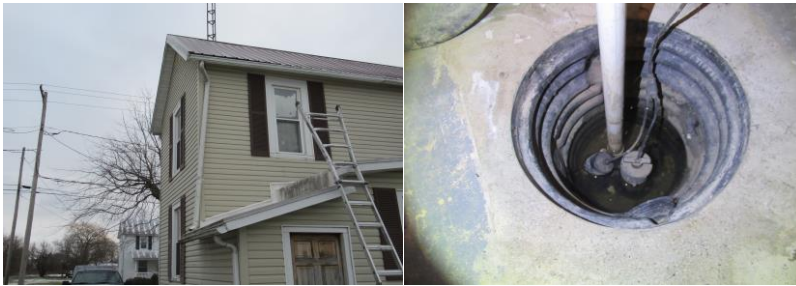
B. Grading and Drainage

The gutters are clear. The downspouts have extensions on them. One of the downspouts will eject water on to the driveway and could be an icy slippery hazard if it is below freezing. The back downspout extension runs water under the deck but stays next to the home. It should get water away from the home. The upper downspout on the rear is loose and the wind is about to knock it off. There is a working sump pump in the basement but there is no back up or emergency sump pump.

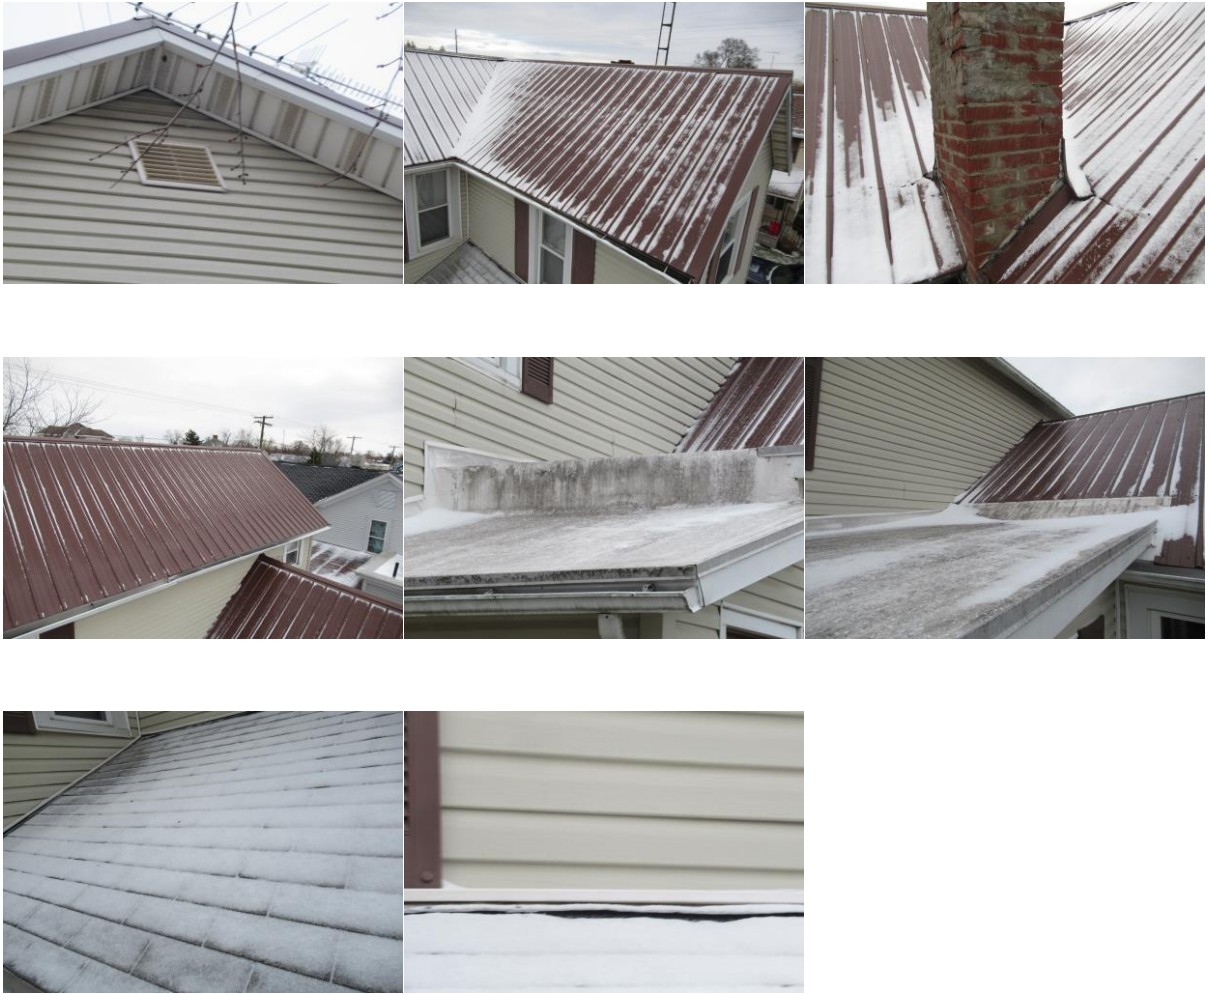
C. Roof Covering Materials

The roof did have a snow cover so I did not walk it. I did use the spectroscope and ladder to view the roof. The roof is ventilated by gable vents. The shingles are sealed down and have most of their protective stone on them. The steel roofing shows no signs of corrosion.

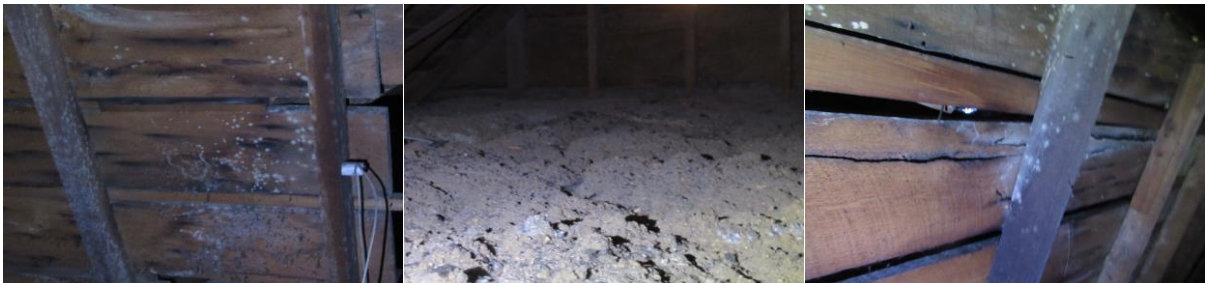
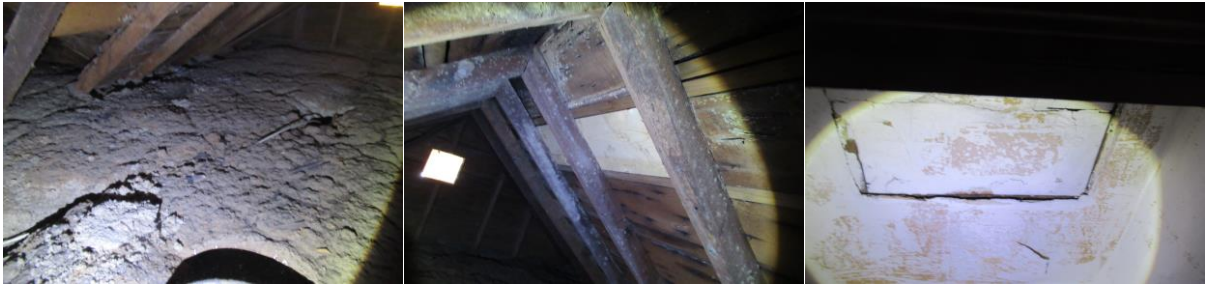
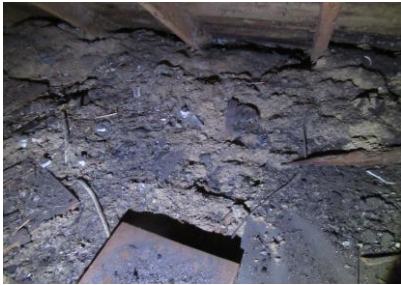
D. Roof Structures and Attics

There is a good amount of insulation in the attic. The attic is ventilated by the gable vents. Some of the roof sheathing boards are cracked and some have been replaced. There are some spots that are possible fungal growth. I can test these spots for mold for a lab fee if needed.

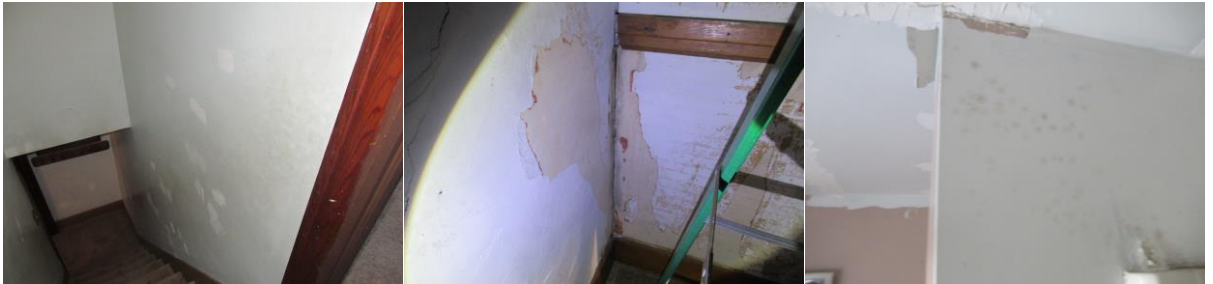
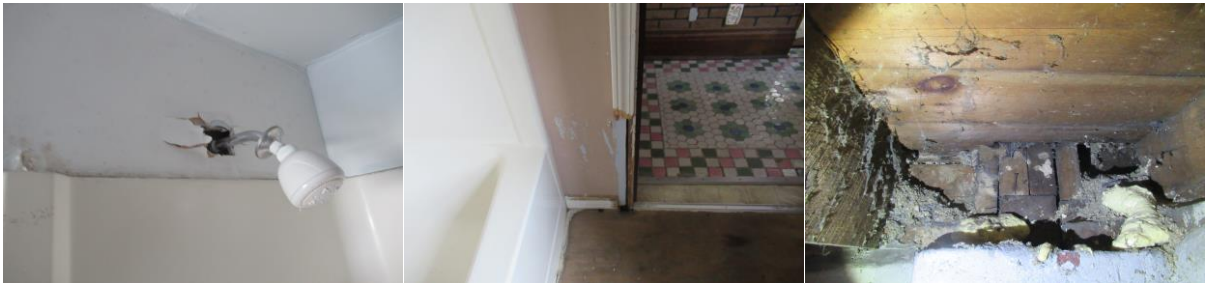
E. Walls (Interior and Exterior)

The interior walls have some repaired spots with no paint. There is peeling paint on the walls in the closets but the moisture meter saw no high moisture content at this time. The bathroom walls have possible fungal growth spots and can be tested for mold if needed. The wall has a hole around the shower head. Some of the trim is broken in the bathroom. Some of the insulation has fallen out of the wall cavities into the basement.

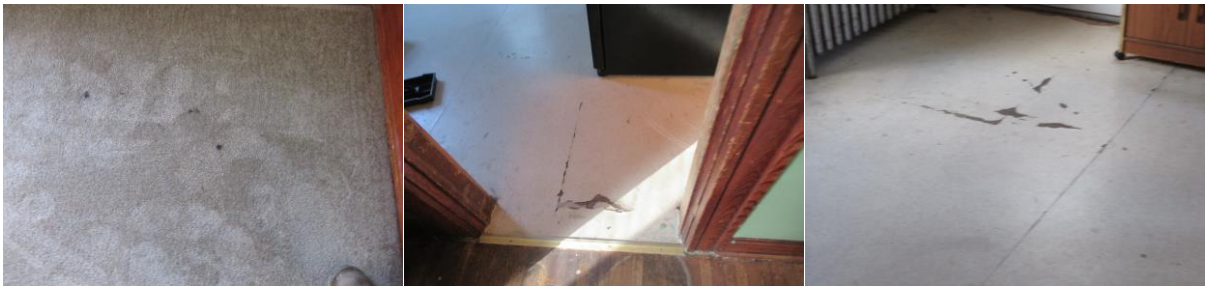
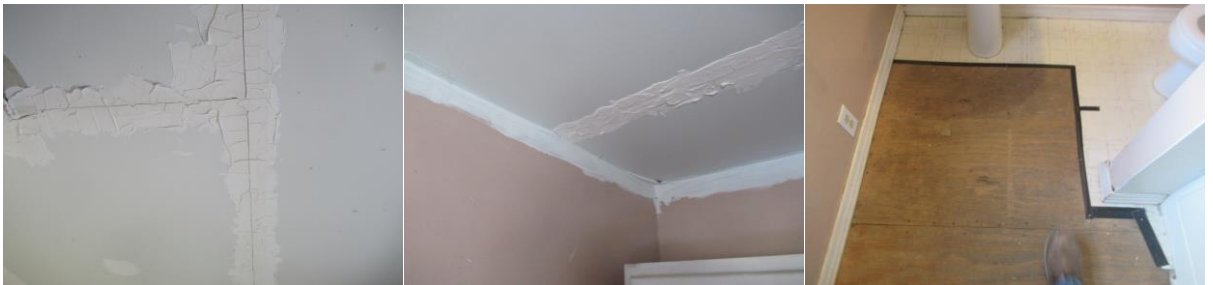
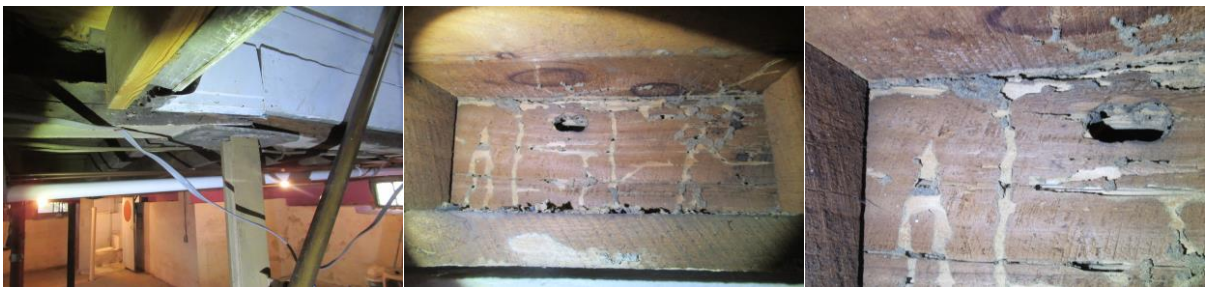
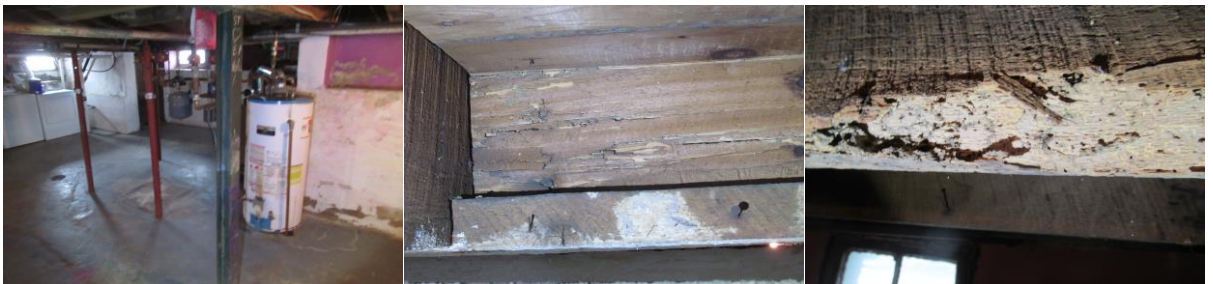
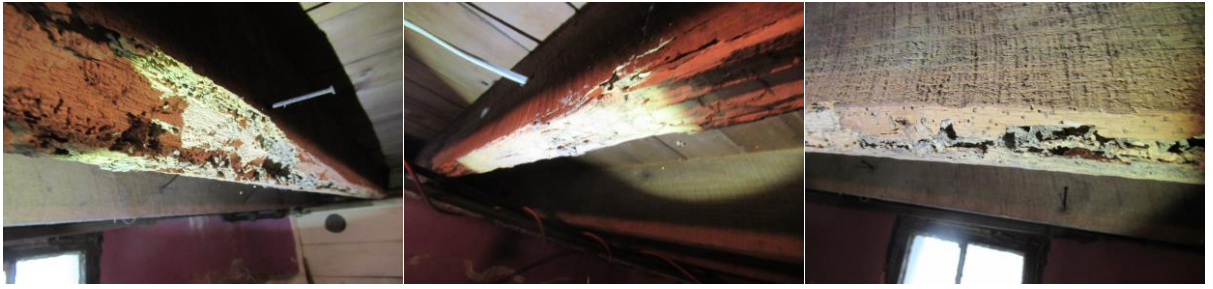
F. Ceilings and Floors

The ceiling is cracked in closets and the bathroom. The moisture meter showed no moisture associated with the cracking at this time. The carpet is stained in several areas of the home. The kitchen flooring is cracked and split. The bathroom floor is missing. The floor joists in the basement have places where there is termite and places where there is carpenter ant damage. There have been floor jack posts added to support the floor better where it has sagged. The floors are not level at this time. I would recommend a exterminator do a treatment even though I did not see any live insects because the damage does look recent enough.

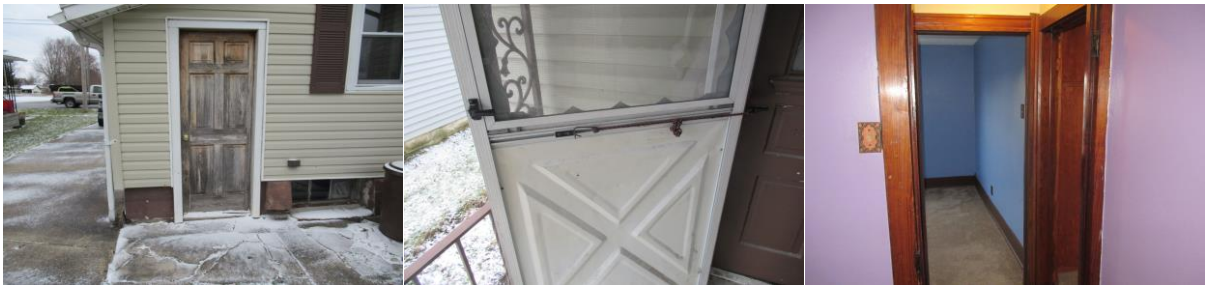
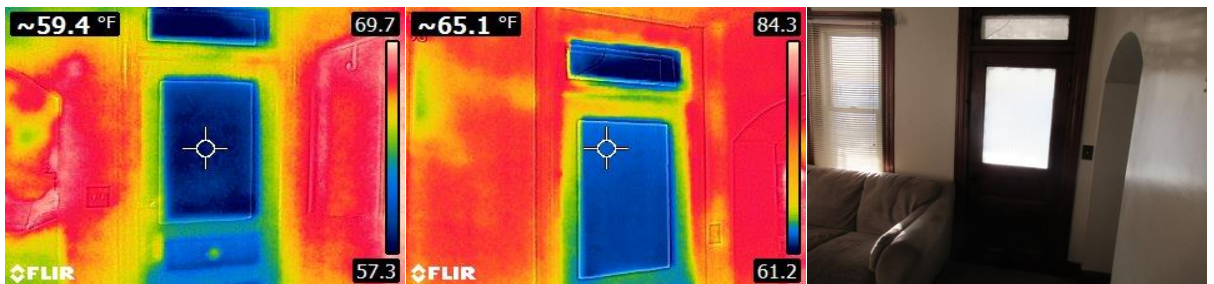
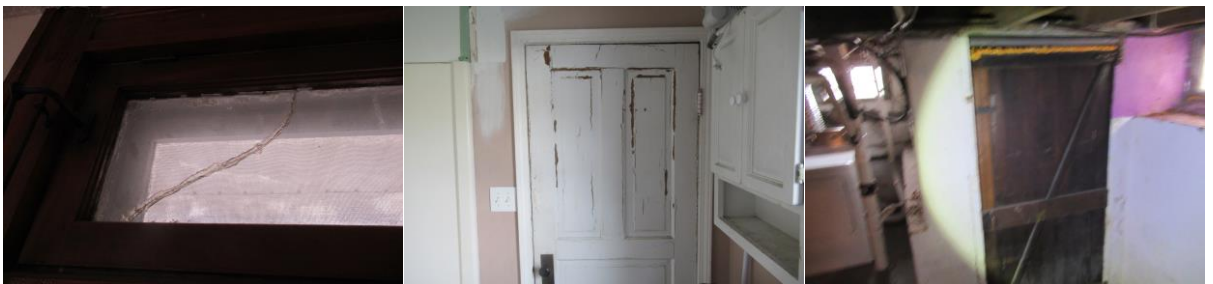
G. Doors (Interior and Exterior)

The back basement door has the paint worn off of it. The front doors are wood with single pane glass and the thermal imaging does show cold air coming in these doors. The interior back basement door does loose a lot of heat and you can feel the cold air when by this door. The front storm door closure is missing. The front door to the side does not operate or open. The transom window above the non operating front door is cracked. The upstairs has some missing interior doors on the bedrooms. The bathroom interior door has peeling paint.

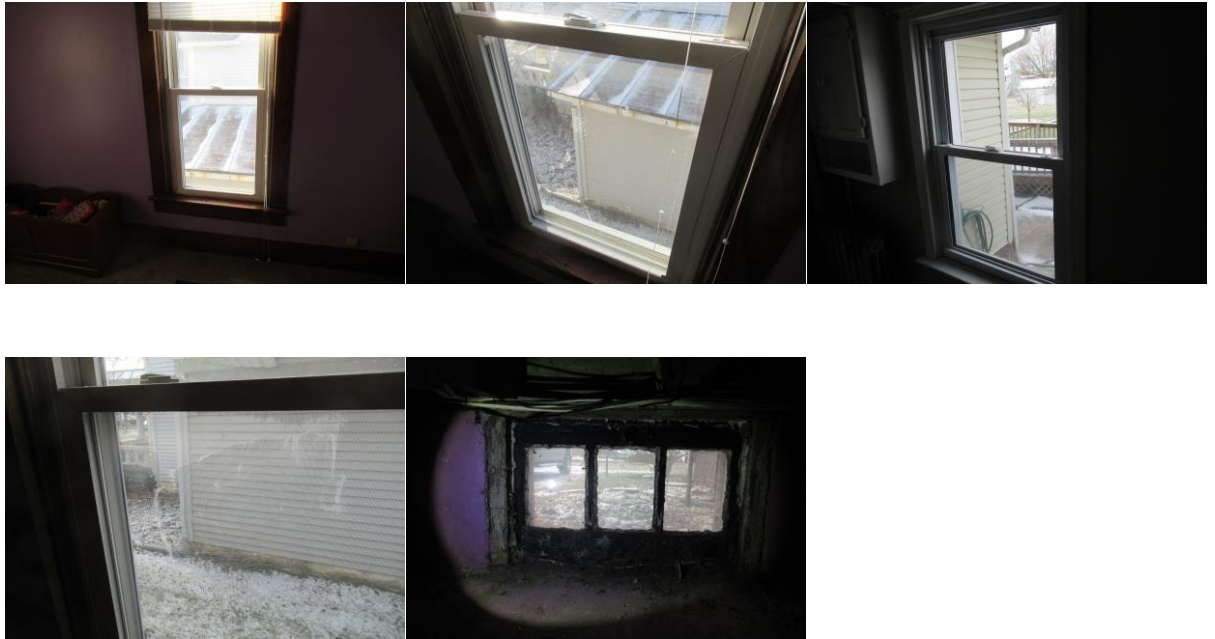
H. Windows

All of the windows except for the basement are vinyl double pane insulated glass windows. The basement windows are wood single pane glass. The bathroom window has broken springs making it difficult to slide open or shut. The screens on several windows have holes or are torn.

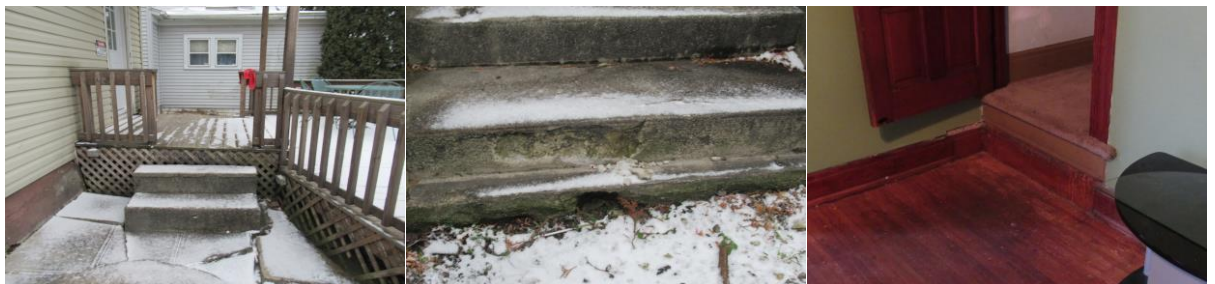
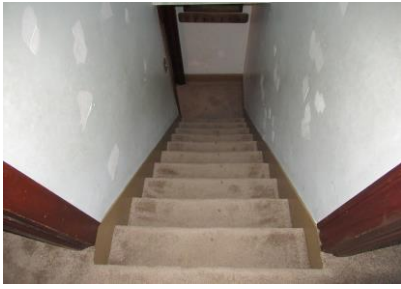
I. Stairways (Interior and Exterior)

The back exterior steps have no railing. The exterior back concrete steps are damaged with crumbling concrete. The interior main stairway has no railing. There is a missing step on the bottom of the main stairway.

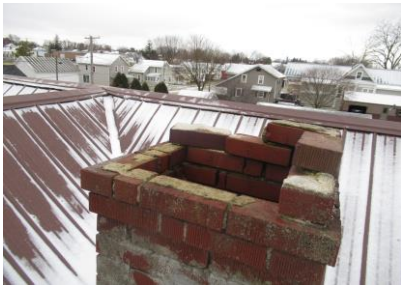
J. Fireplaces and Chimneys

There is no fireplace but there is a chimney the water heater and boiler use for exhaust. The top of the chimney has no cap and the brick are loose and falling.

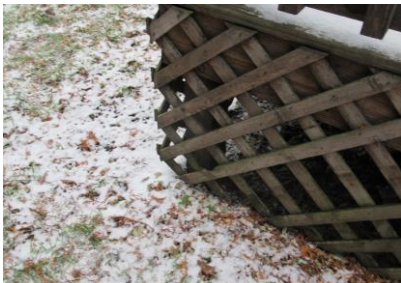
K. Porches, Balconies, Decks and Carports

The back deck has 4x4 post. 4x4 post are not treated as much as 6x6 and will rot off faster.

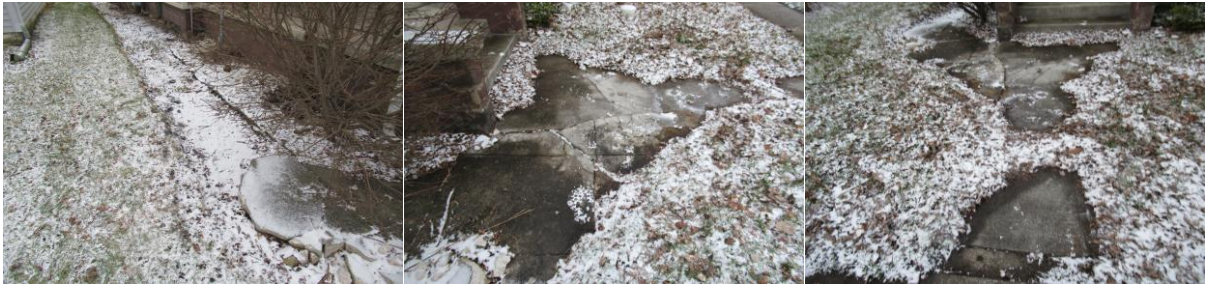
L. Other

The front sidewalk is cracked and in need of repair. The side sidewalk has been dug up and is now gone.

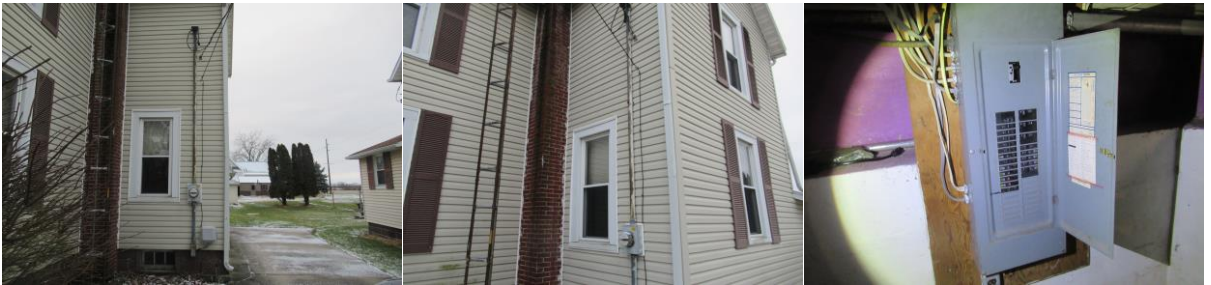
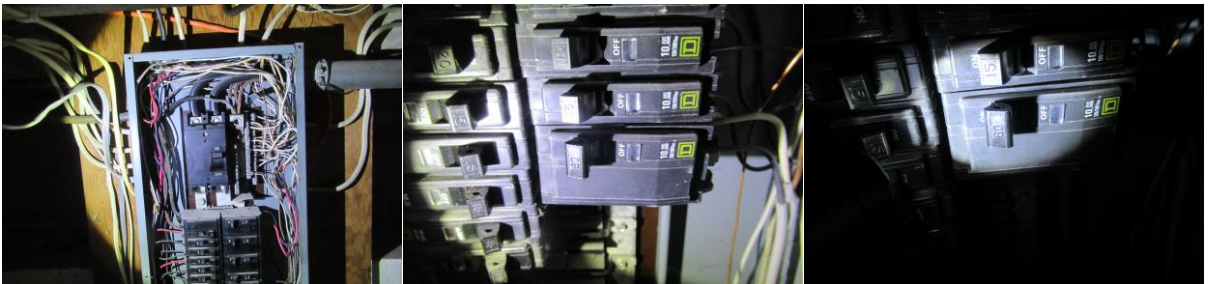
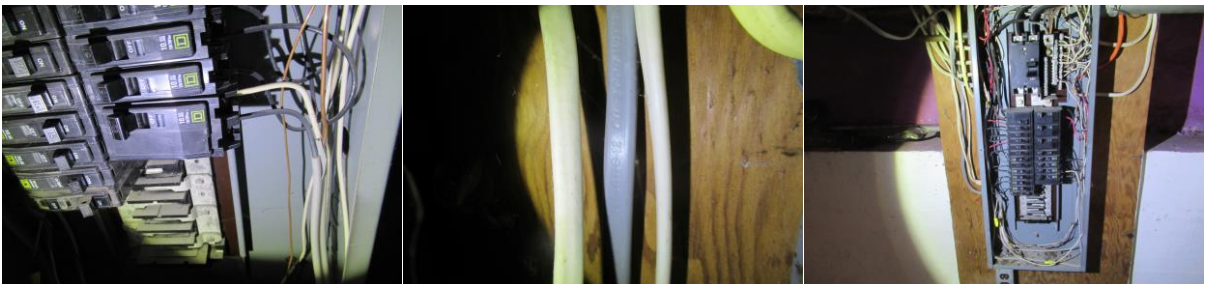
A. Service Entrance and Panels

Home has a 200 amp service with a 200 amp Square D QO Service panel. The electrical pipe that used for the mast is corroded. The service panel has a 60 amp breaker connected to a 12 gage wire. This wire is only rated for 20 amps and needs a 20 amp breaker or a bigger wire. There is no corrosion in the electrical box at this time.

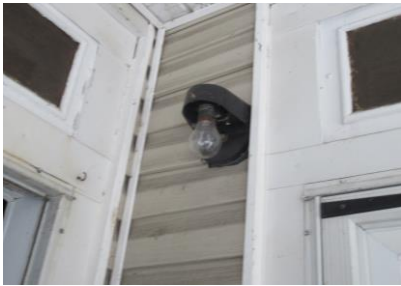
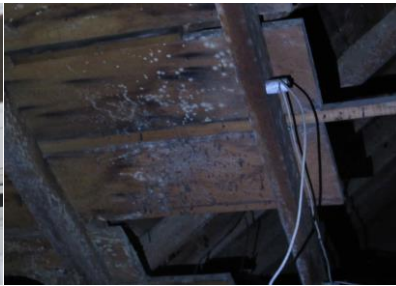
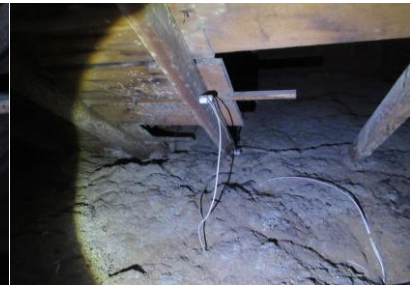
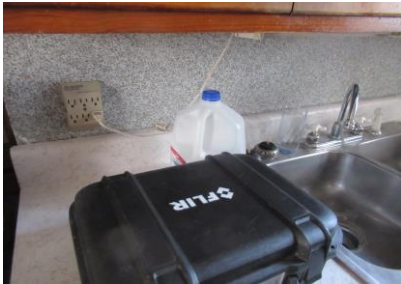
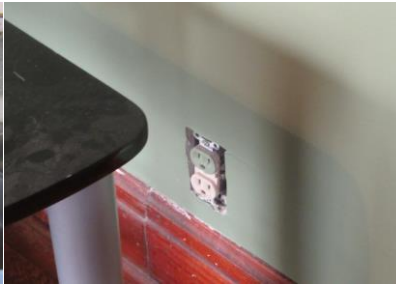
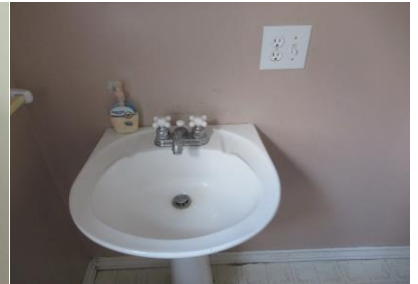
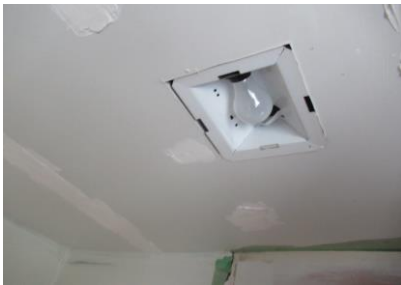
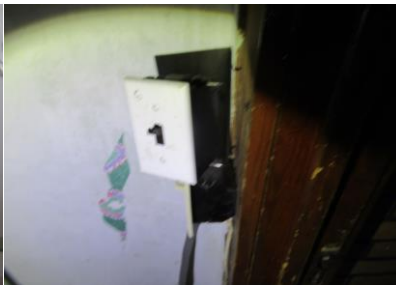
B. Branch Circuits, Connected Devices and Fixtures

The front outdoor light is missing the globe. Most of the outlets are grounded. There are only a couple of upstairs and a couple of outlets downstairs that have open grounds. Only plug three prong cords into grounded outlets. Two prong cords can go into any outlet. There are no GFCI (Ground Fault Circuit Interrupter) protected outlets on the exterior or by the kitchen sink and bathroom sink. In the attic I did find some active knob and tube wiring. Some insurance companies will not insure homes with knob and tube. The dining room has an outlet with no cover. The bathroom light has no cover. One of the switches leading to the basement is in a loose box that needs secured.

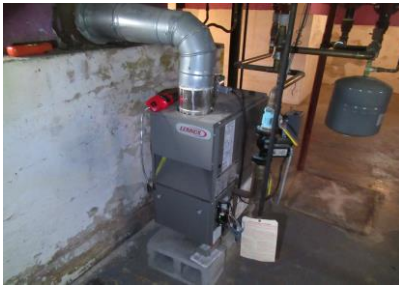
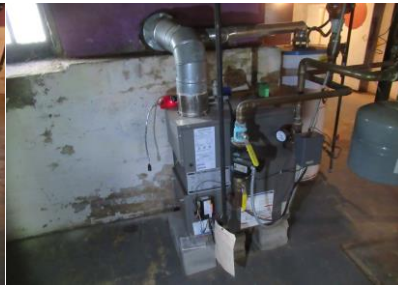
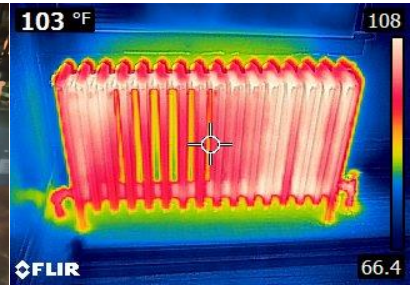
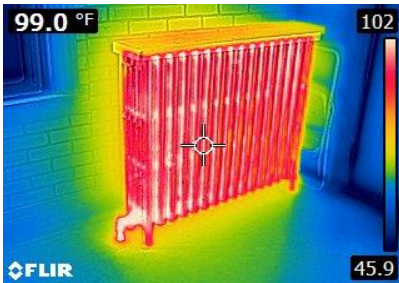
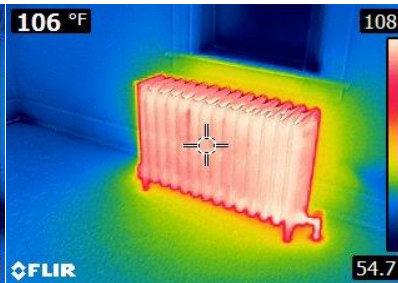
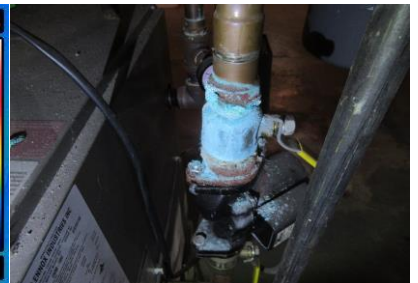
A. Heating Equipment

The mid efficient Lennox boiler is dated at 2007. The system is operational and the thermal imaging did show hot water in the radiators at this time. There is a cooper pipe that has a lot of corrosion next to the boiler. All HVAC equipment does need serviced at least once a year.

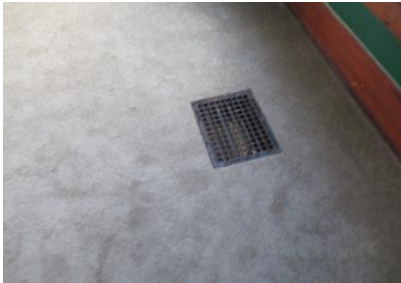
C. Duct Systems, Chases, and Vents

There is no duct work with the heating coming from a boiler. The upstairs gets heat from the open vents in the floor that allow heat to rise up through the home.

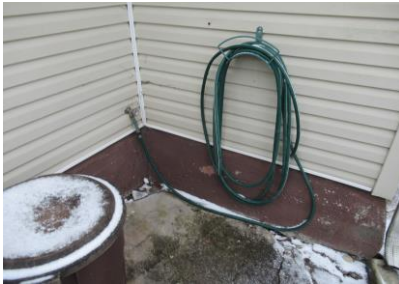
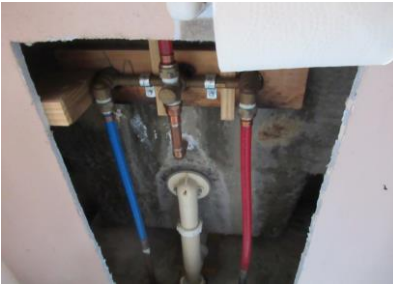
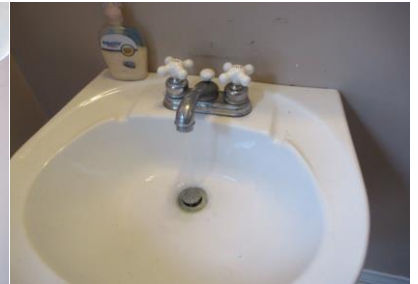
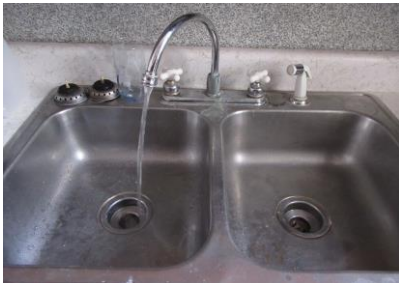
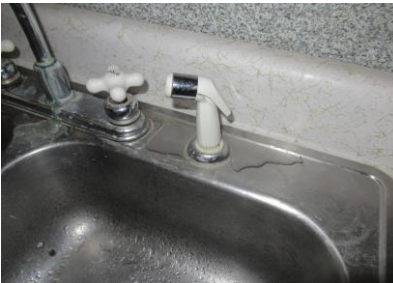
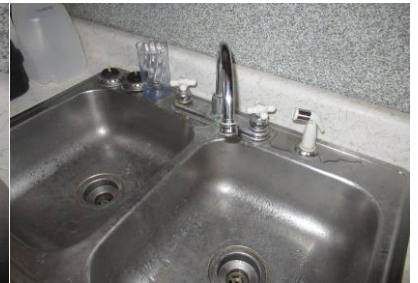
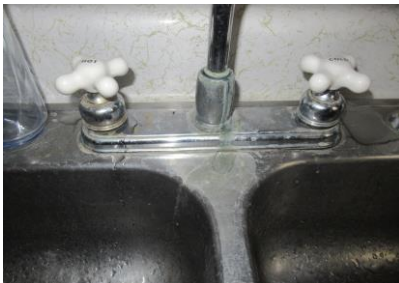
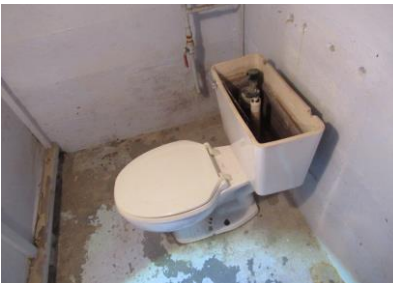
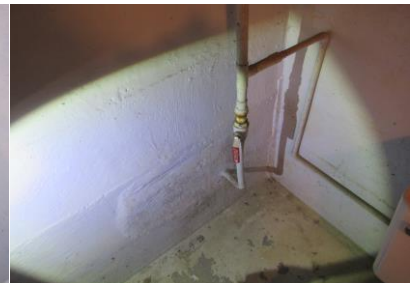
A. Plumbing Supply, Distribution Systems and Fixtures

The exterior water spigot on the back has the hose hooked up to it yet and the air temperature is below freezing. This could freeze and damage this spigot. I did not find any leaks in the plumbing pipes at this time. The bathroom sink faucet drips. The kitchen sink faucet leaks at the handle and the middle of the faucet. The kitchen sink sprayer also leaks. The basement toilet is missing the tank cover. The main water shut off is at the front of the basement by the basement toilet.

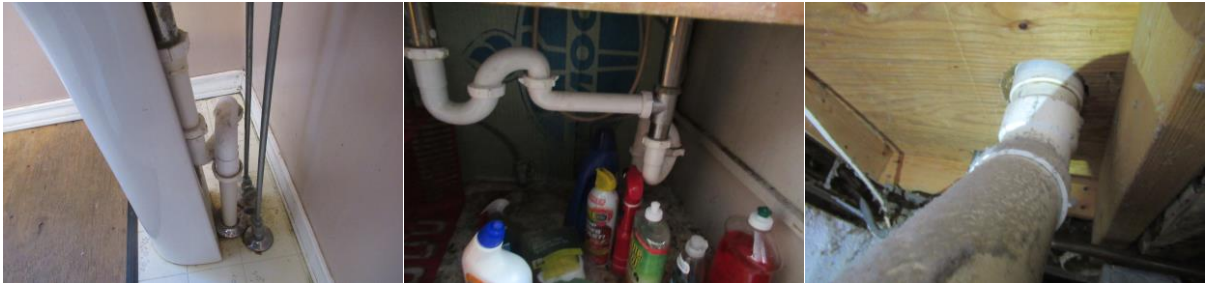
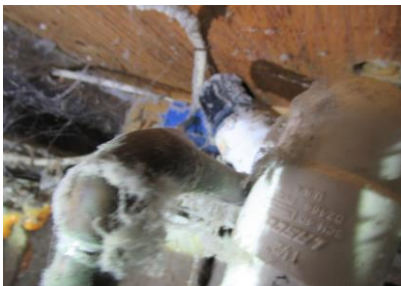
B. Drains, Wastes, and Vents

The traps are S-Traps which are common in older homes but when water is draining a vacuum can occur and eliminate all water from these traps on rare occasions which is why newer homes have P-Traps. I did not find any leaks in the drains at this time. There is no plumbing vent line that is usually required on a homes drain system. There is a air intake that is usually used on manufactured homes but on a home there should be an actual air admittance valve if using it this way. A home should have a vent ran for the plumbing system to operate correctly.

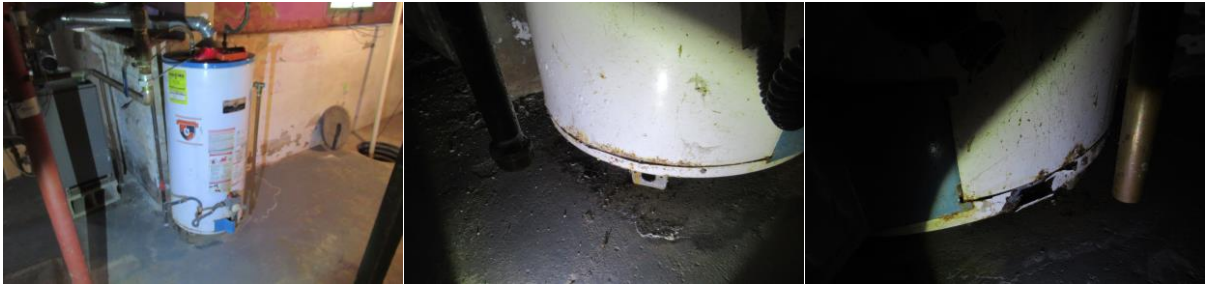
C. Water Heating Equipment

The U.S. Craftmaster water heater is dated at 1991. This is an older water heater that would be near the end of its expected life. The water heater is operational at this time. The bottom is corroded and there are some water stains on the basement floor indicating it may be leaking at this time.

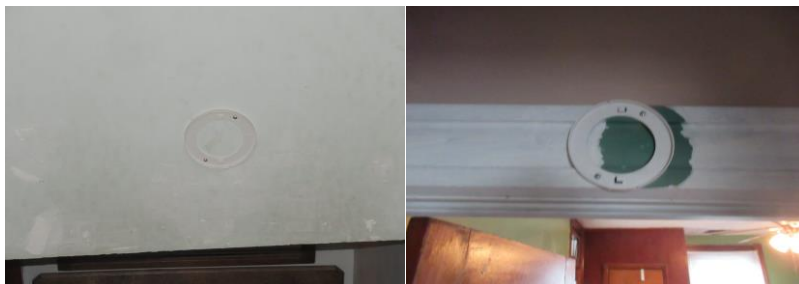
I. Other

There are no smoke alarms or carbon monoxide alarms and there should be both for safety.
